**TUNNEL EXAMINATION REPORT  
PHOTOGRAPHS OF STRUCTURE**

ELR : MER Br. No. : 00

Mileage : 03 M 37 ch Sheet 41 of 79

<b>ELR:</b>	BLE	<b>Structure No:</b>		<b>Mileage:</b>	187m 64ch	<b>Examination date:</b>	14/11/17
<b>Route:</b>	Barnstaple Branch Line					<b>OS ref:</b>	SS 871 261
<b>Name:</b>	East Anstey Tunnel					<b>Type:</b>	Tunnel

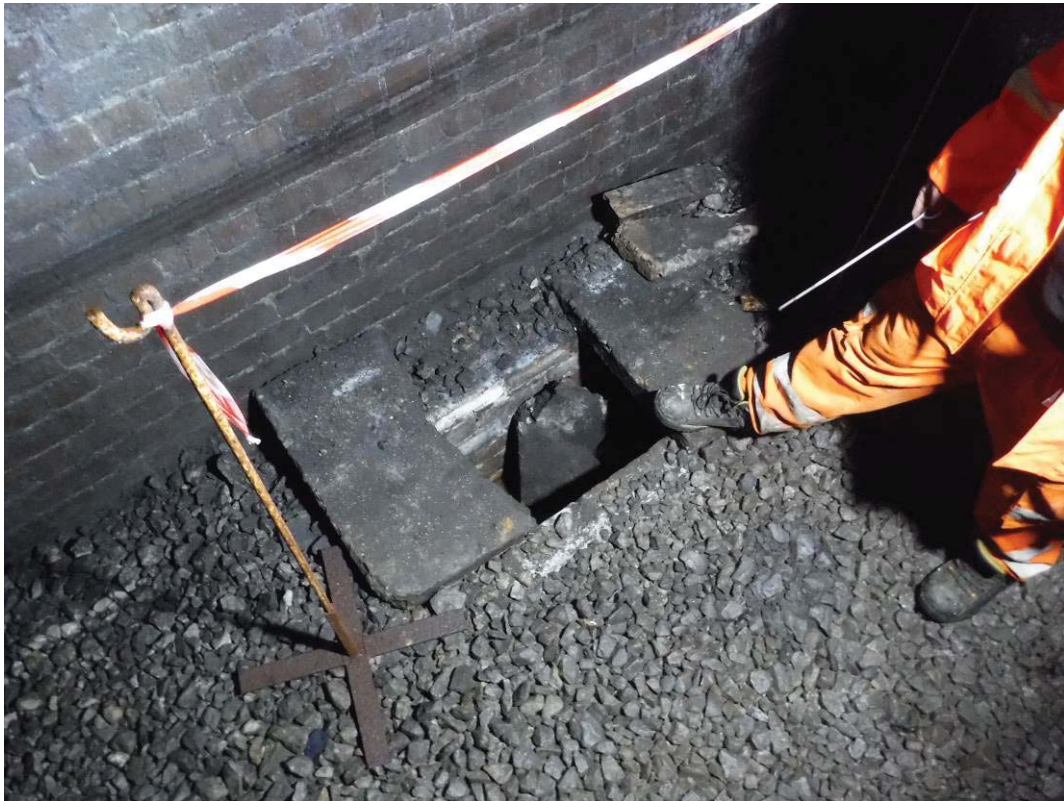
**Photo No.91:** 034+16 Cess Up, Open catch-pit.

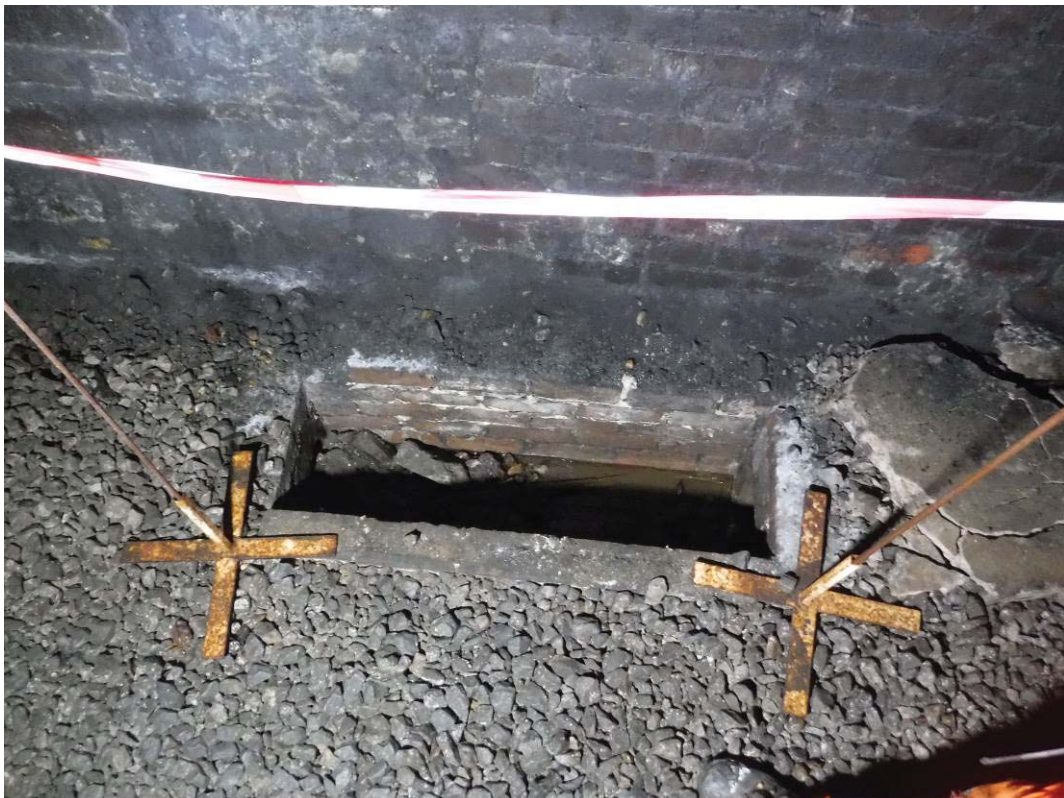
**Photo No.92:** 035+17 Cess Up, Open catch-pit.

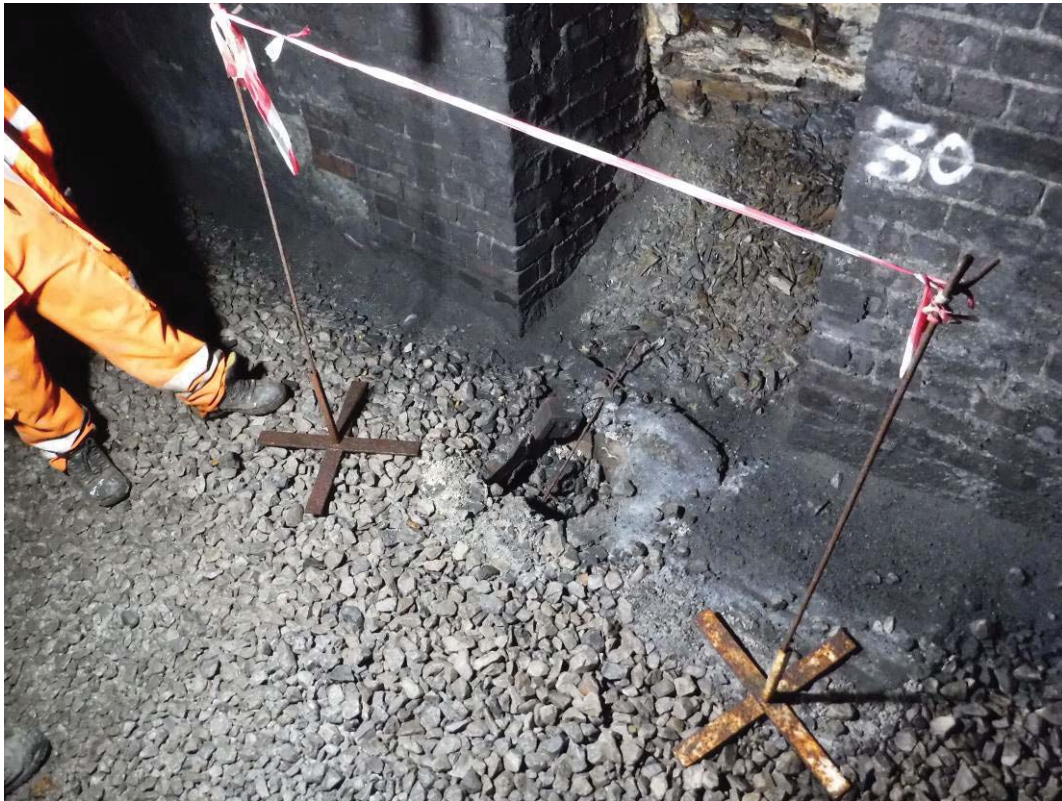
**Photo No.93:** 037+18 Cess Up, Open catch-pit.

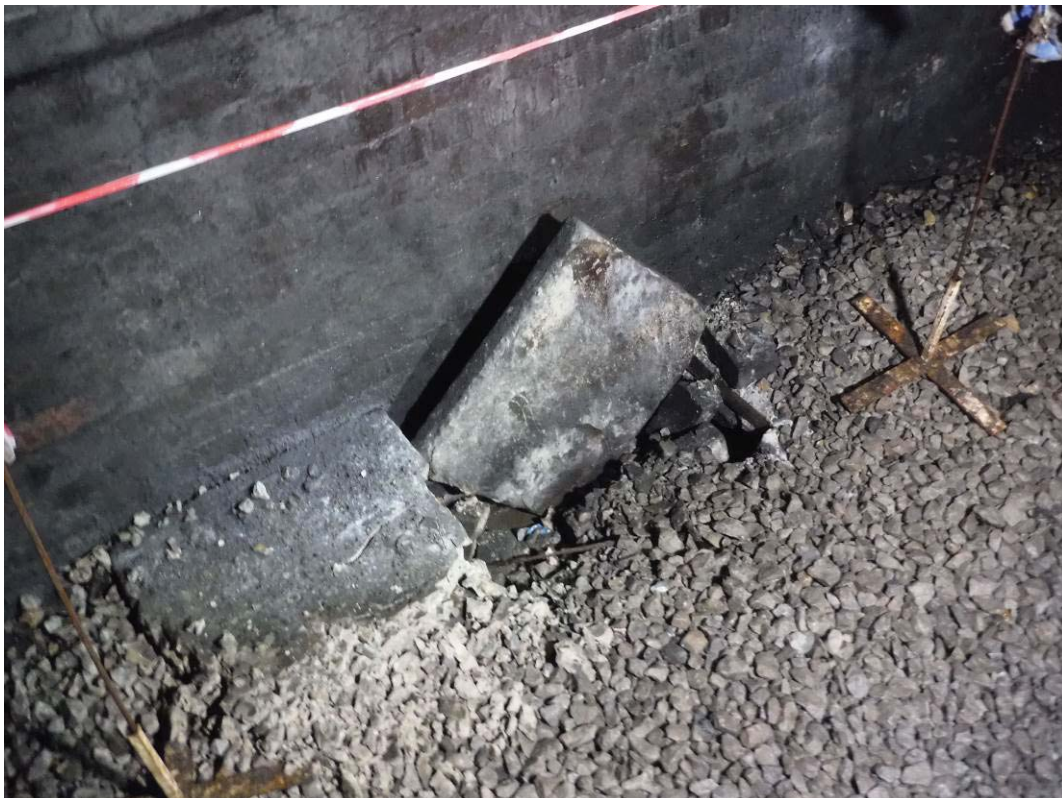
**Photo No.94:** 038+15 Cess Up, Open catch-pit.

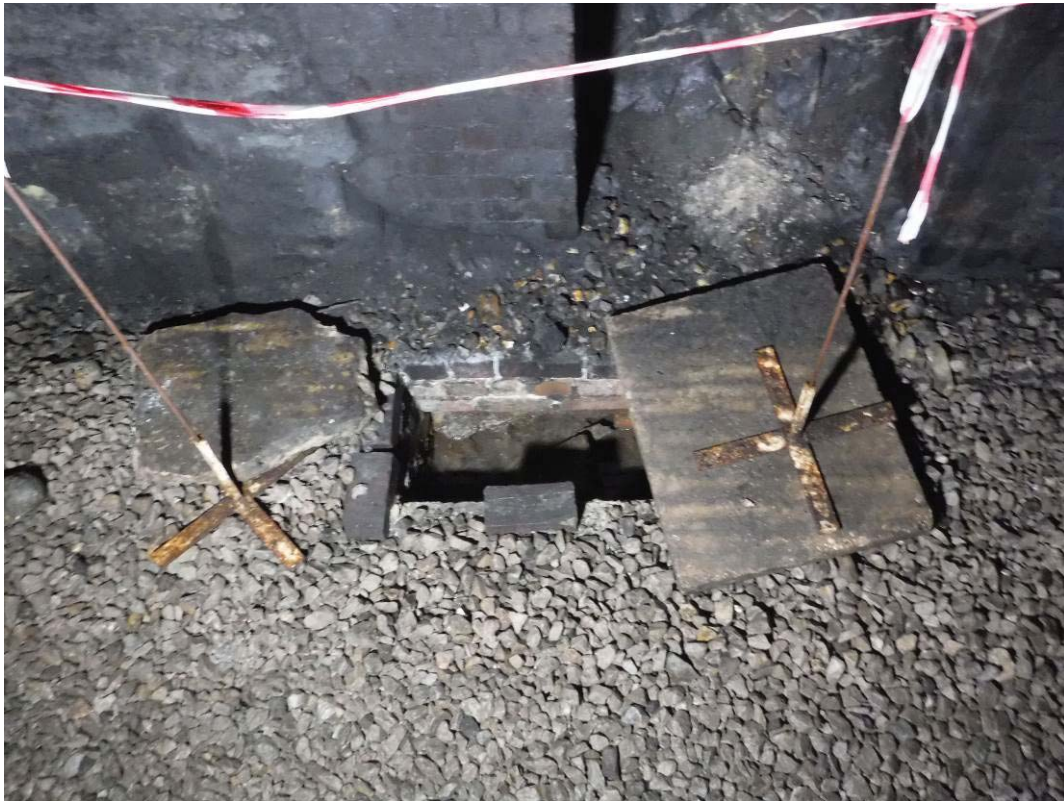
**Photo No.95:** 042+21 Cess Up, Open catch-pit.

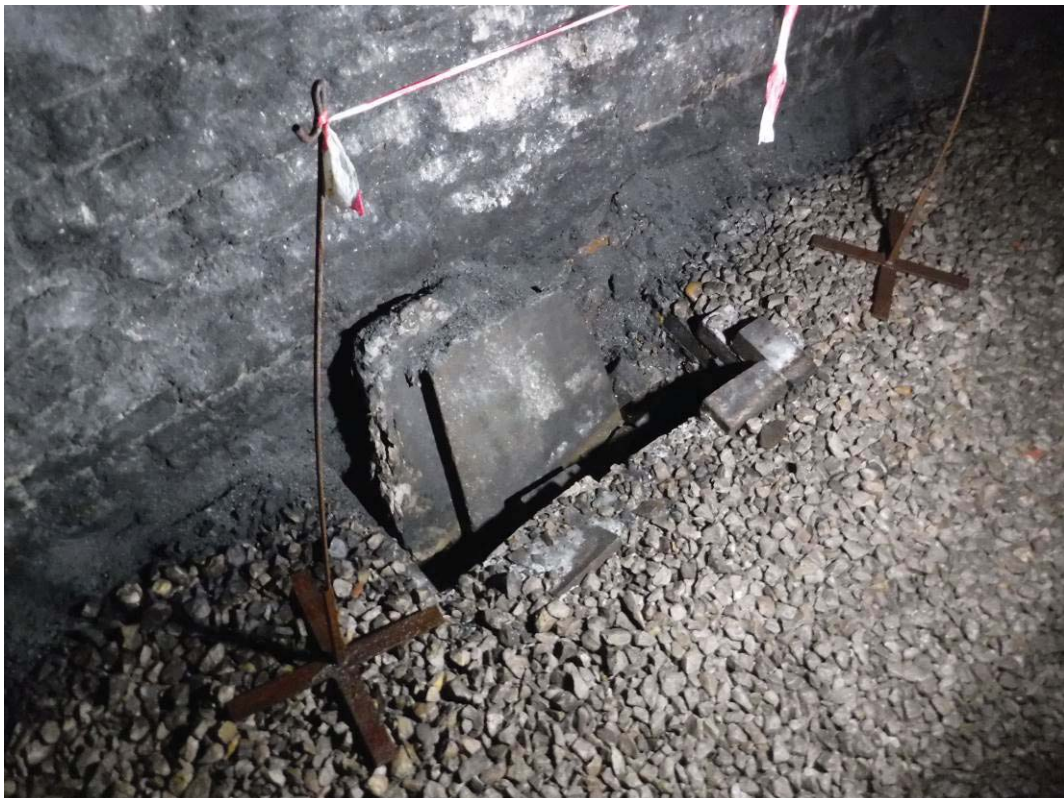
**Photo No.96:** 043+17 Cess Up, Open catch-pit.

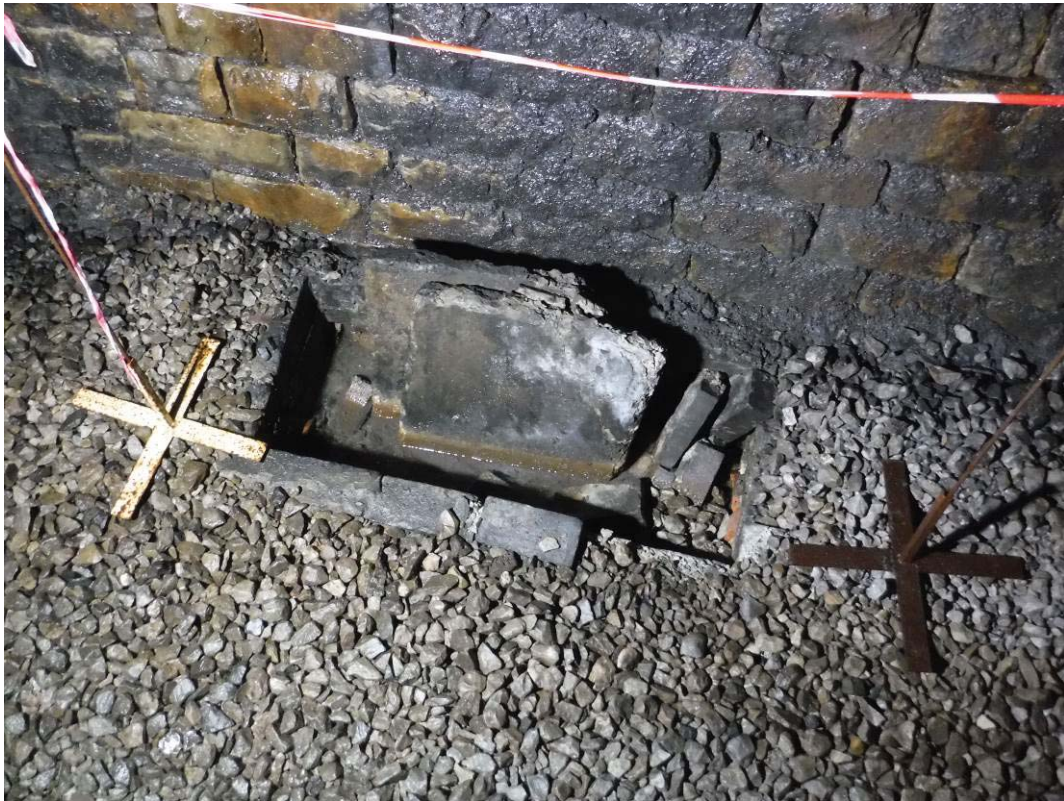
**Photo No.97:** 045+15 Cess Up, Open catch-pit.

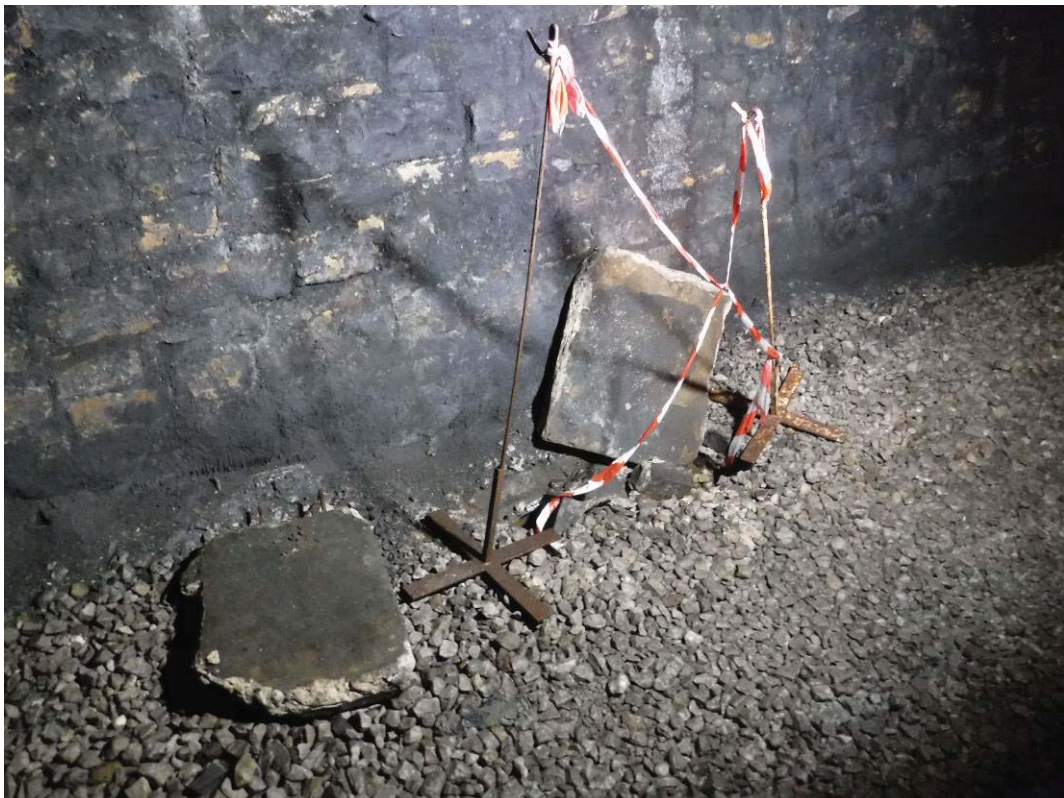
**Photo No.98:** 046+15 Cess Up, Open catch-pit.

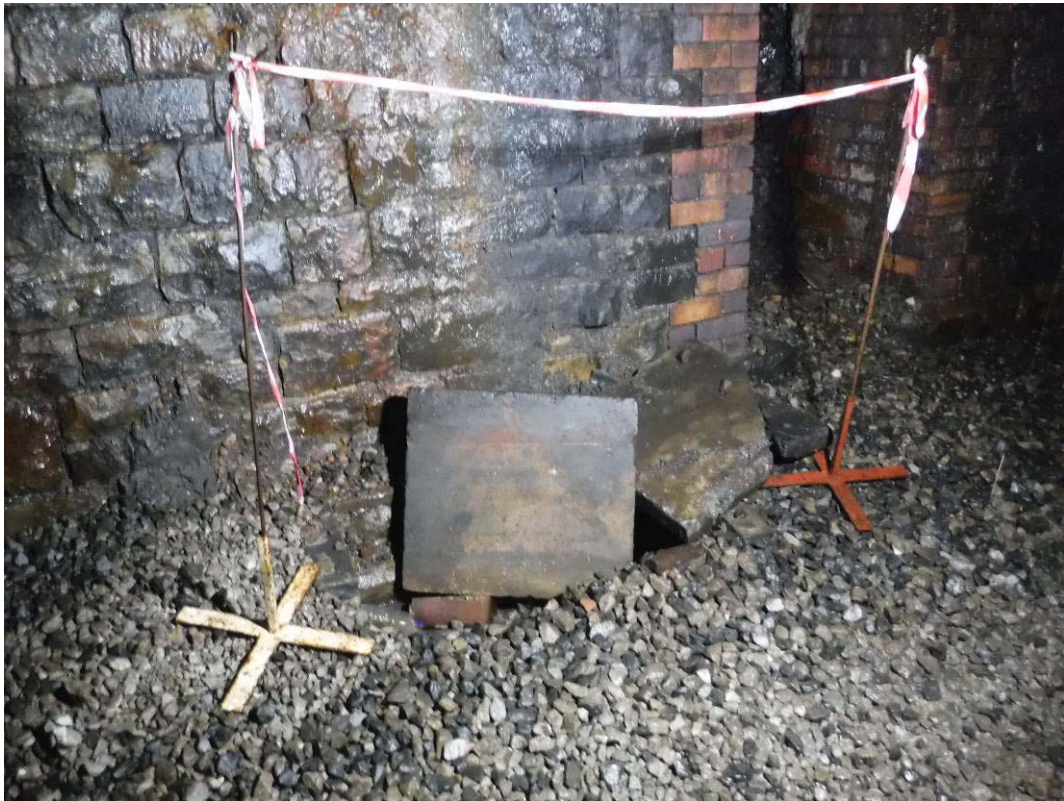
**Photo No.99:** 047+15 Cess Up, Open catch-pit.

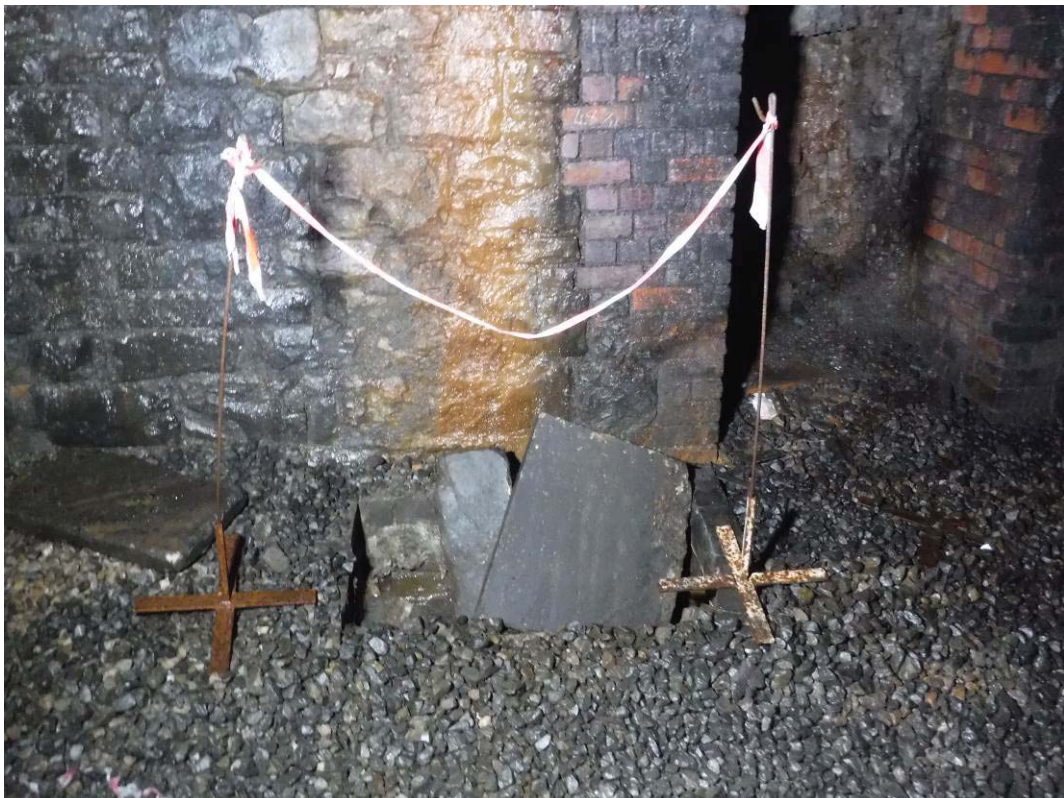
**Photo No.100:** 048+17 Cess Up, Open catch-pit.

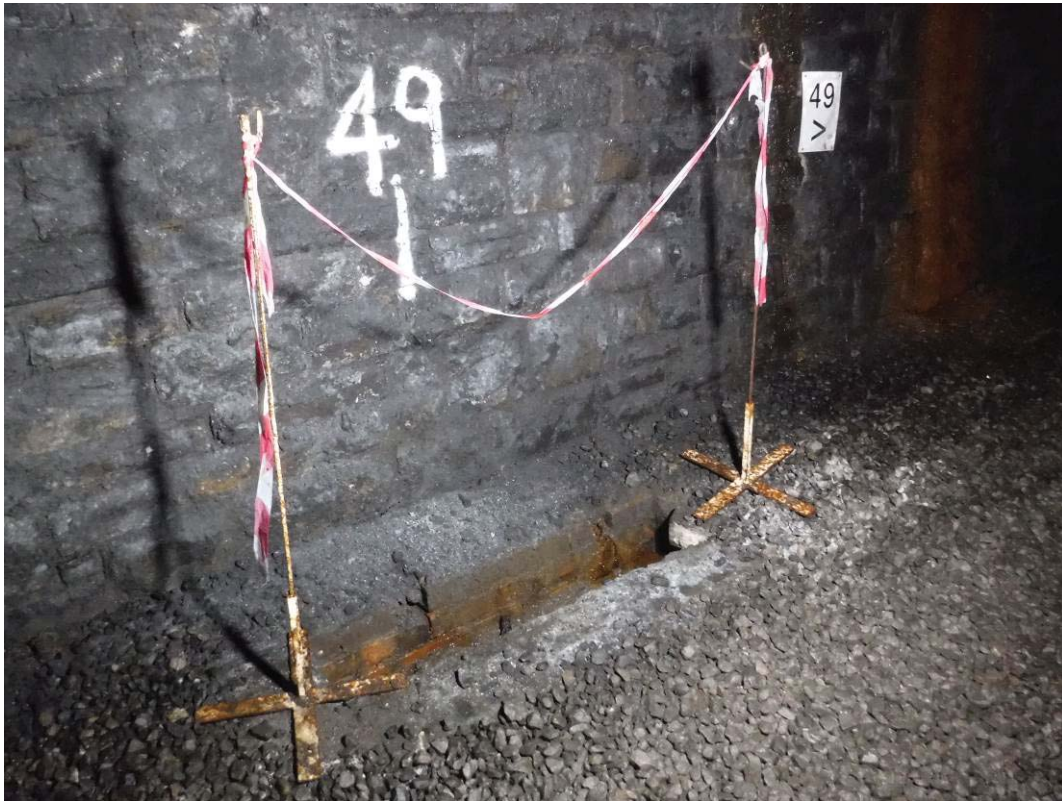
**Photo No.101:** 049+02 Cess Down, Open catch-pit.

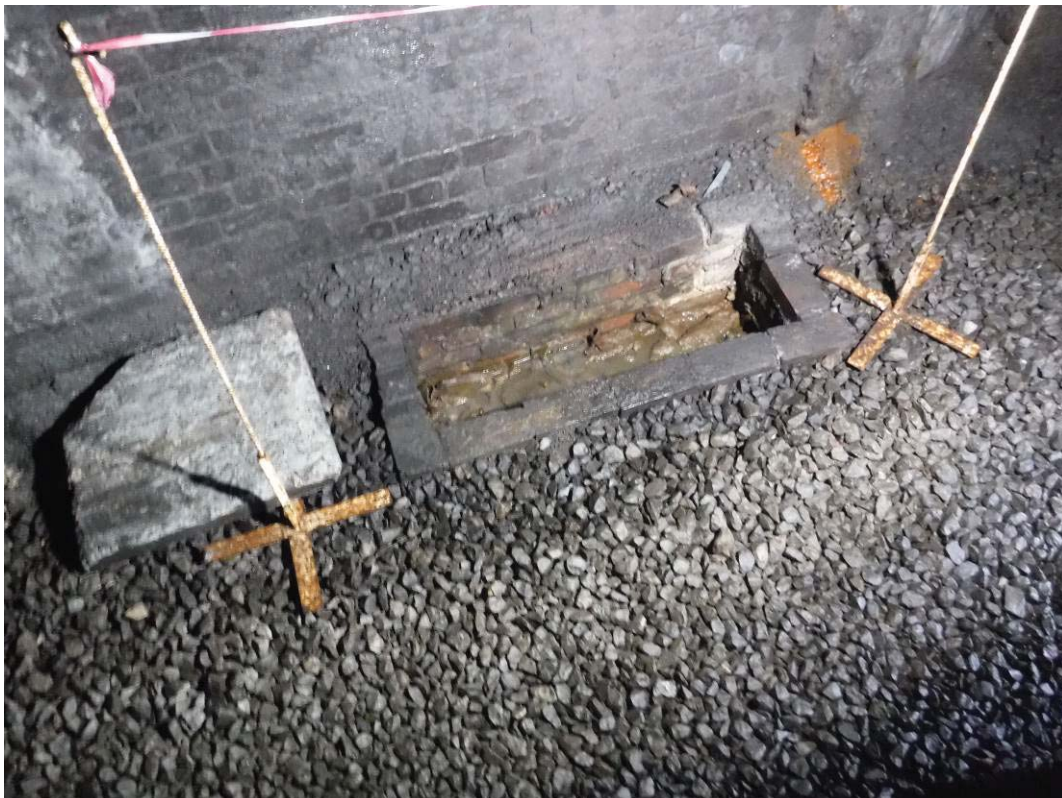
**Photo No.102:** 052+17 Cess Up, Open catch-pit.

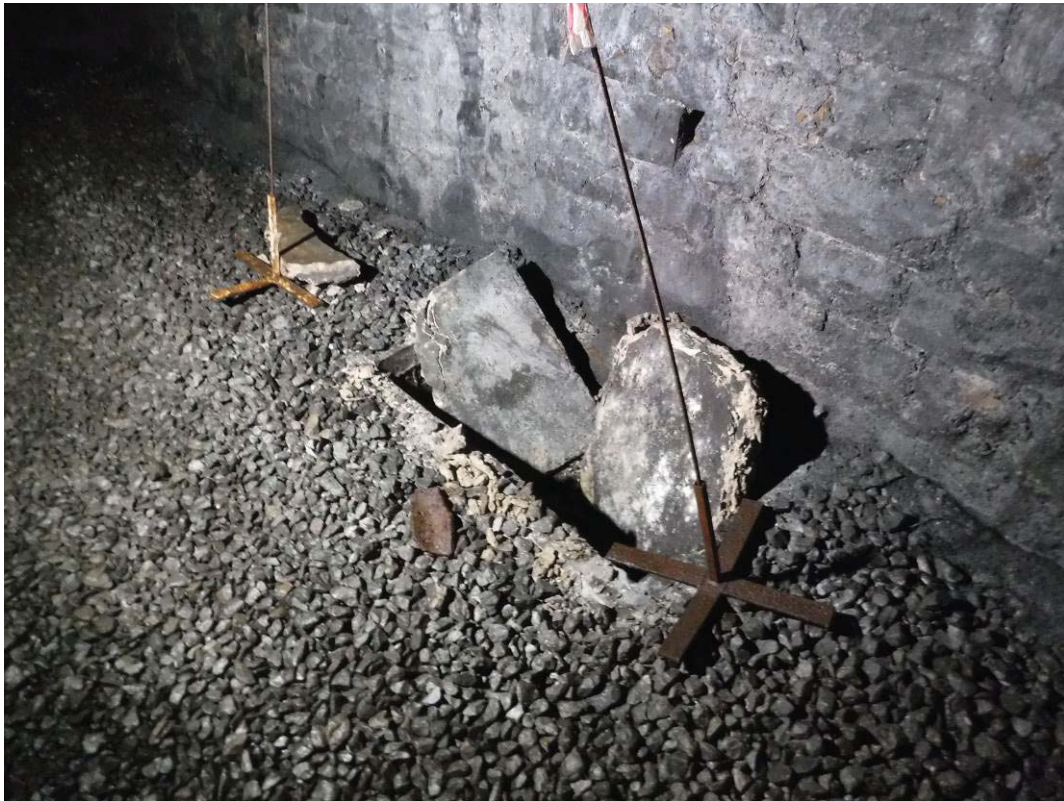
**Photo No.103:** 050+16 Cess Up, Open catch-pit.

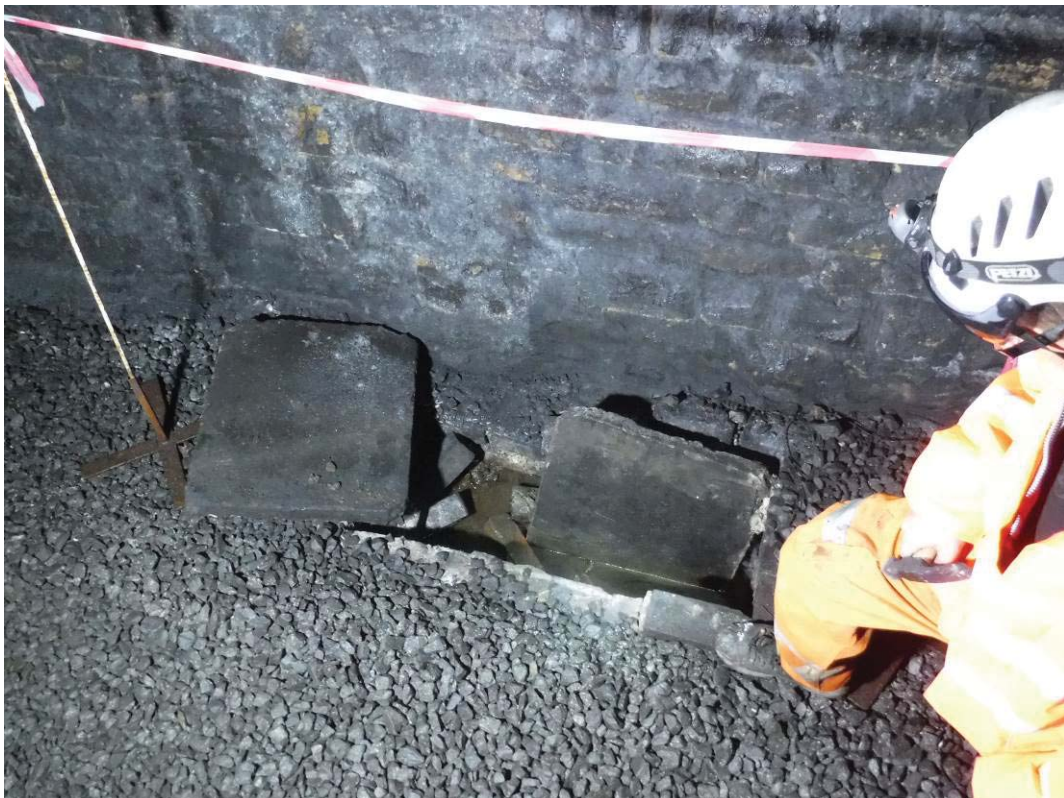
**Photo No.104:** 054+17 Cess Up, Open catch-pit.

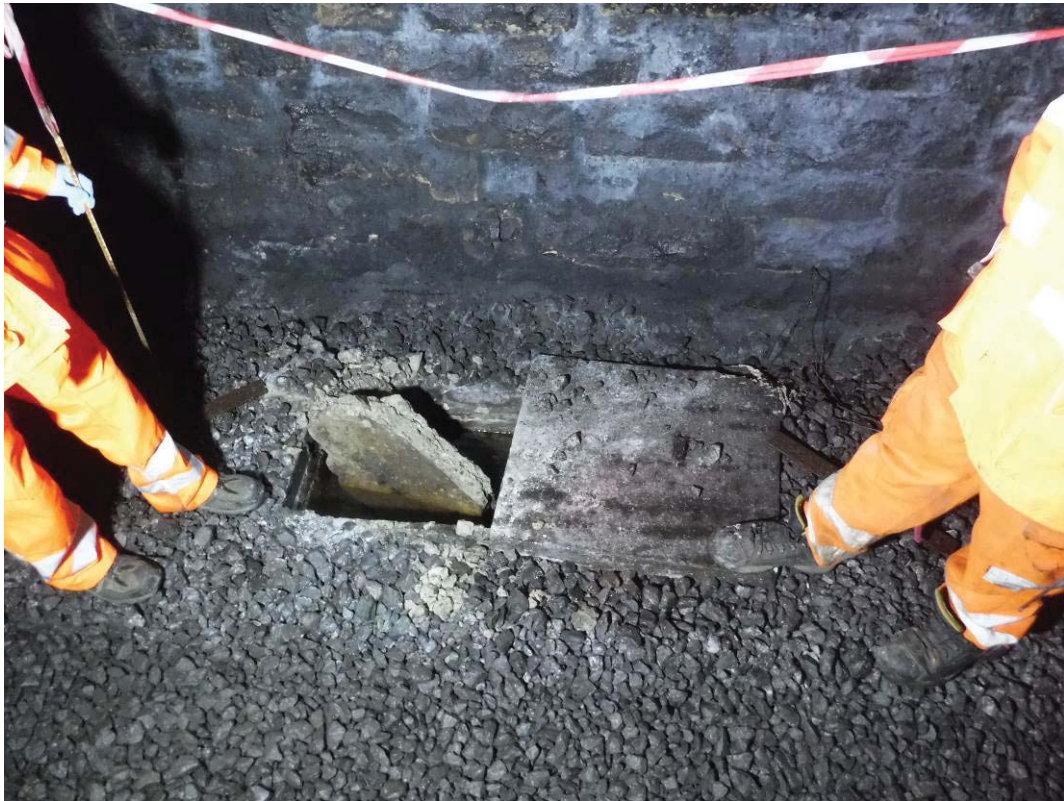
**Photo No.105:** 055+16 Cess Up, Open catch-pit.

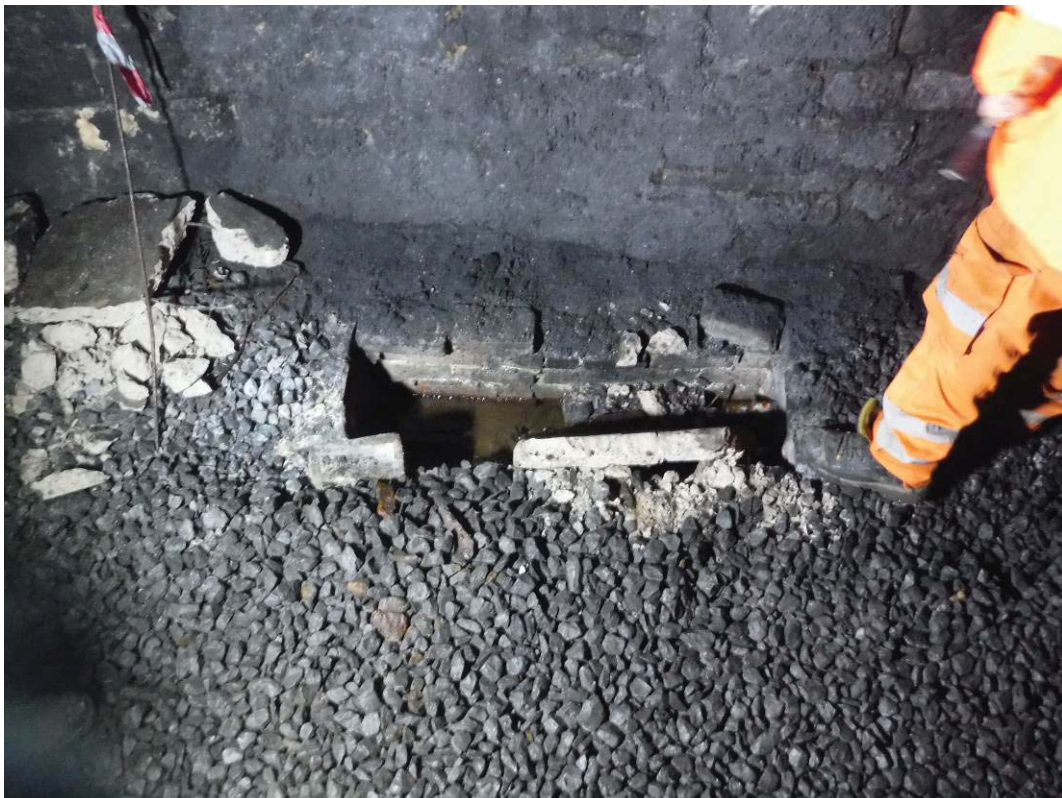
**Photo No.108:** 058+18 Cess Up, Open catch-pit and partially blocked, water flowing towards NE.

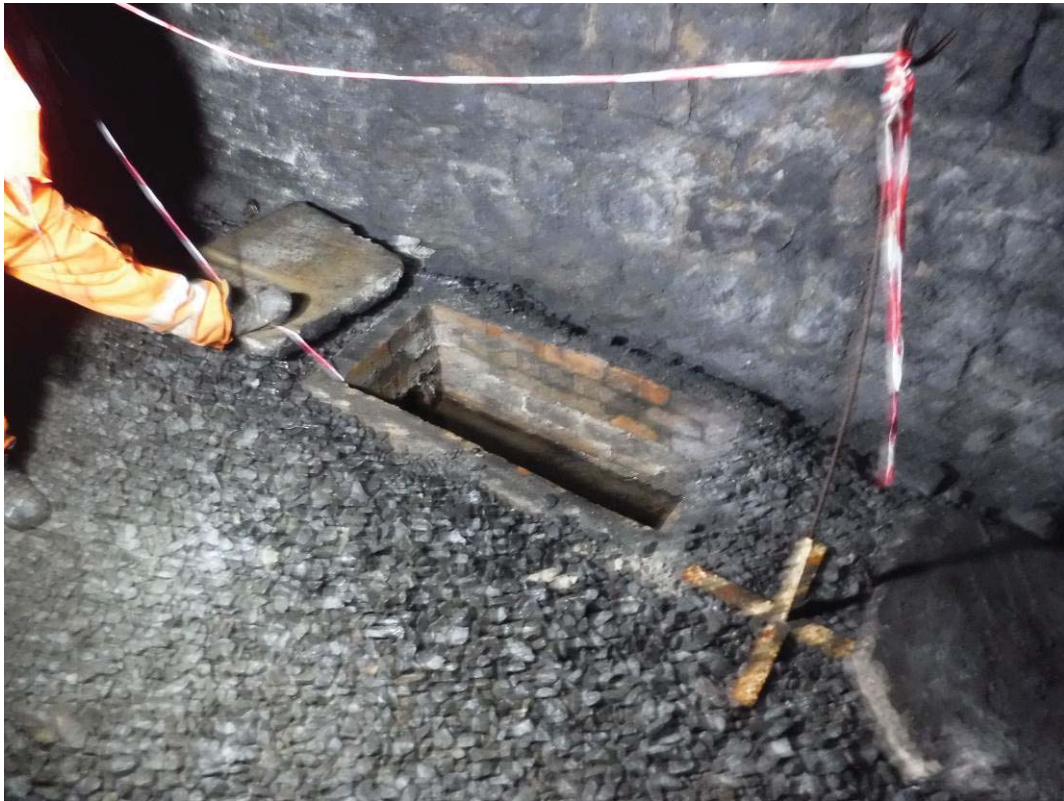
**Photo No.109:** 059+17 Cess Up, Open catch-pit.

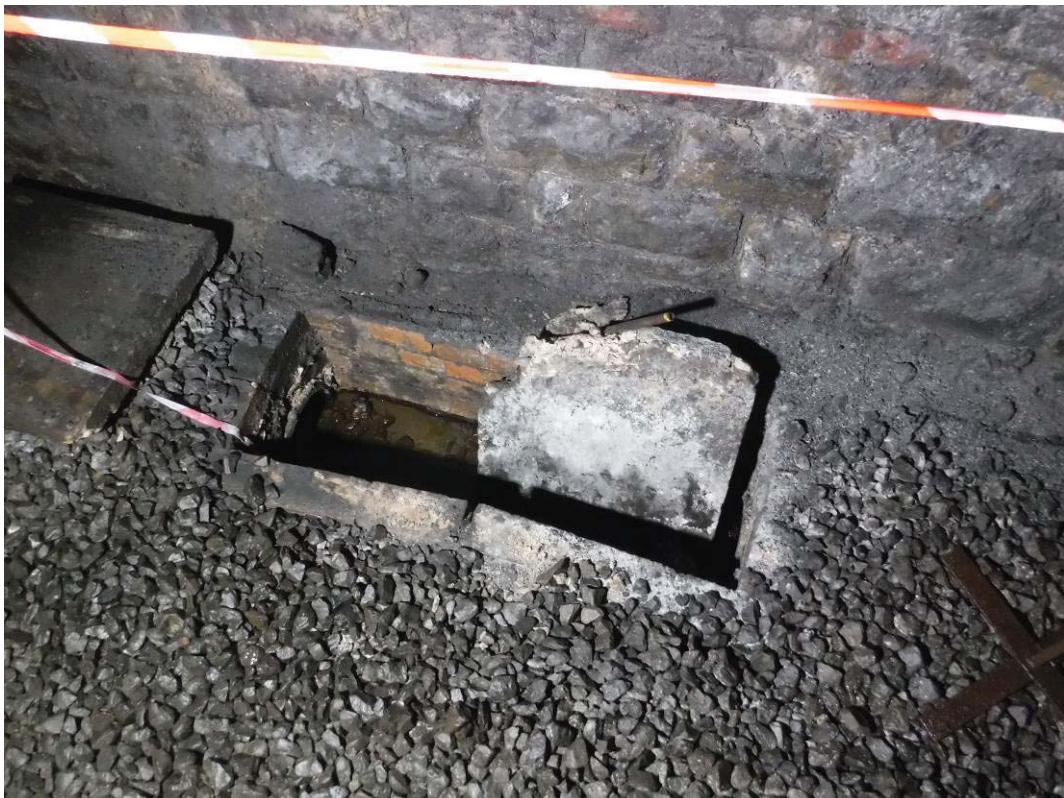
**Photo No.110:** 060+16 Cess Up, Open catch-pit.

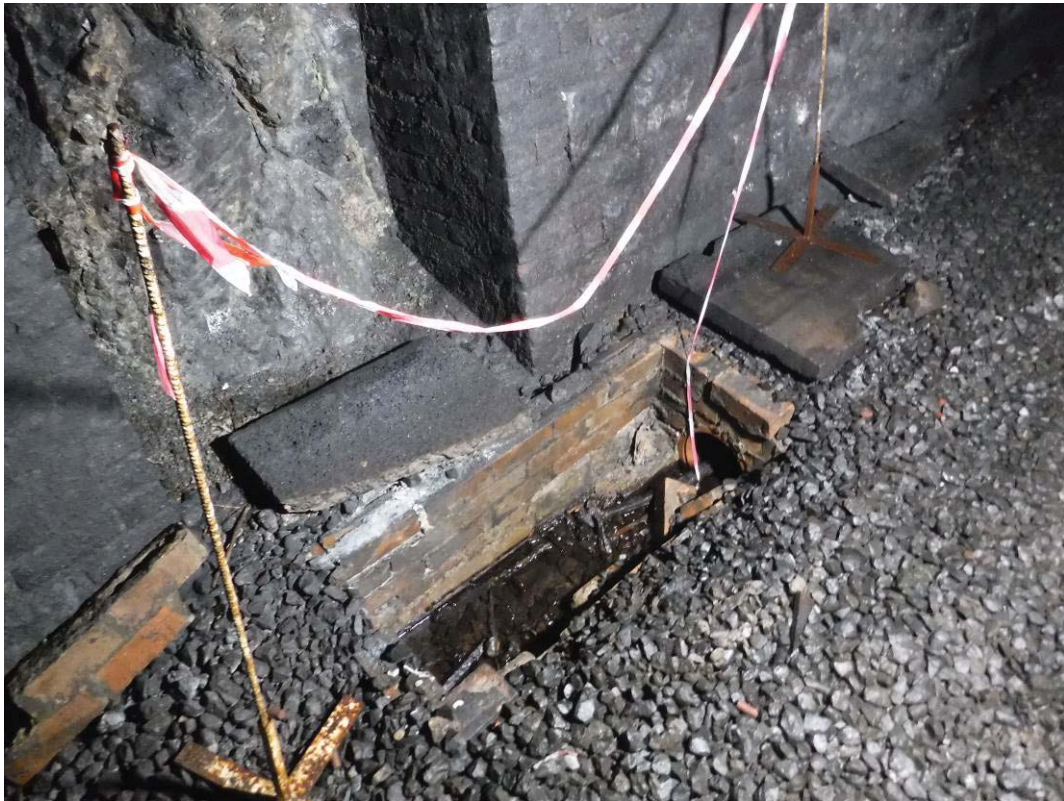
**Photo No.111:** 061+15 Cess Up, Open catch-pit.

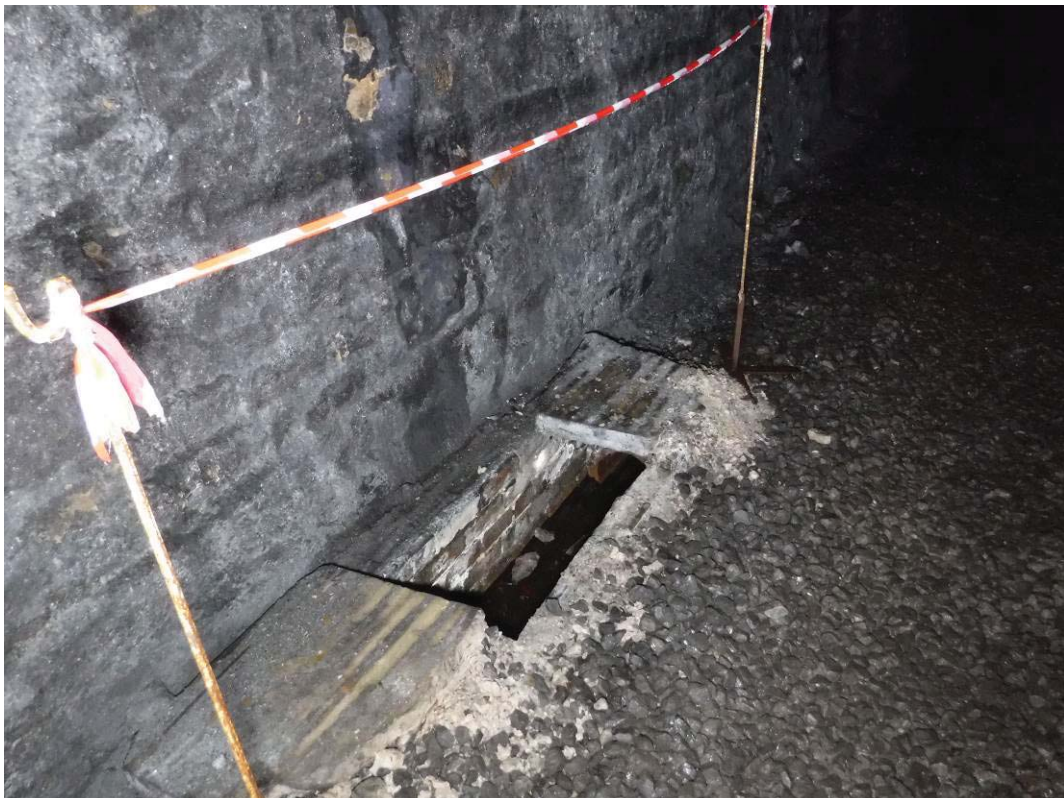
**Photo No.112:** 062+16 Cess Up, Open catch-pit.

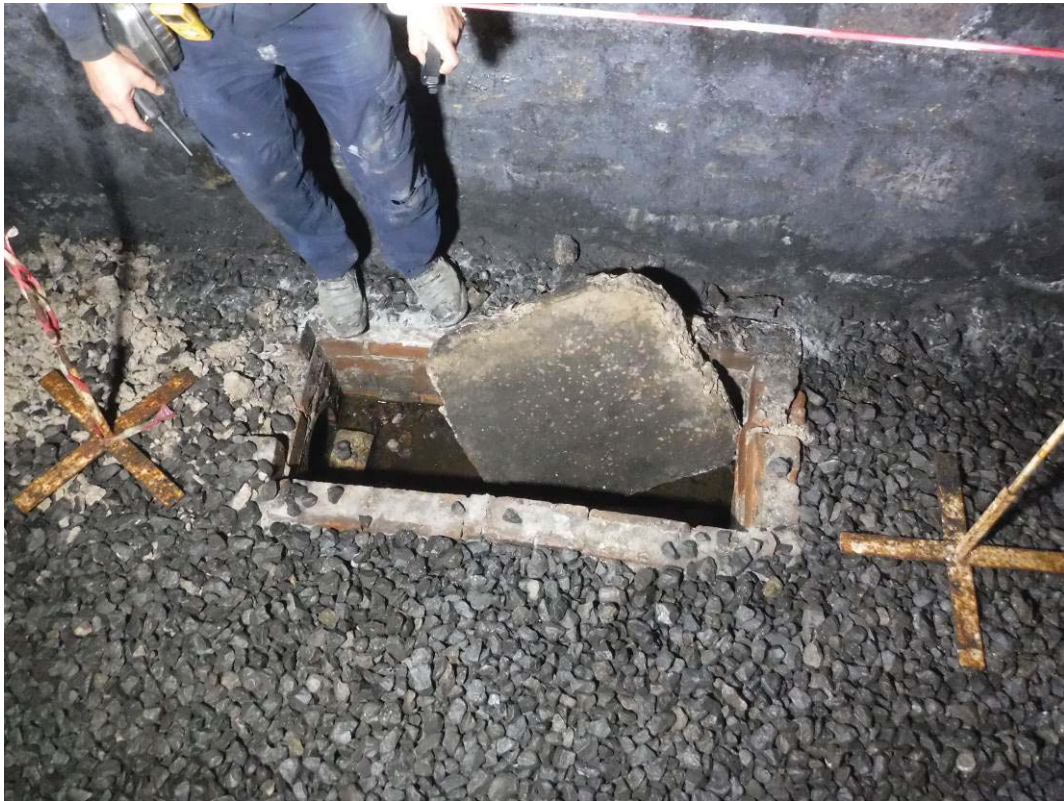
**Photo No.113:** 064+17 Cess Up, Open catch-pit.

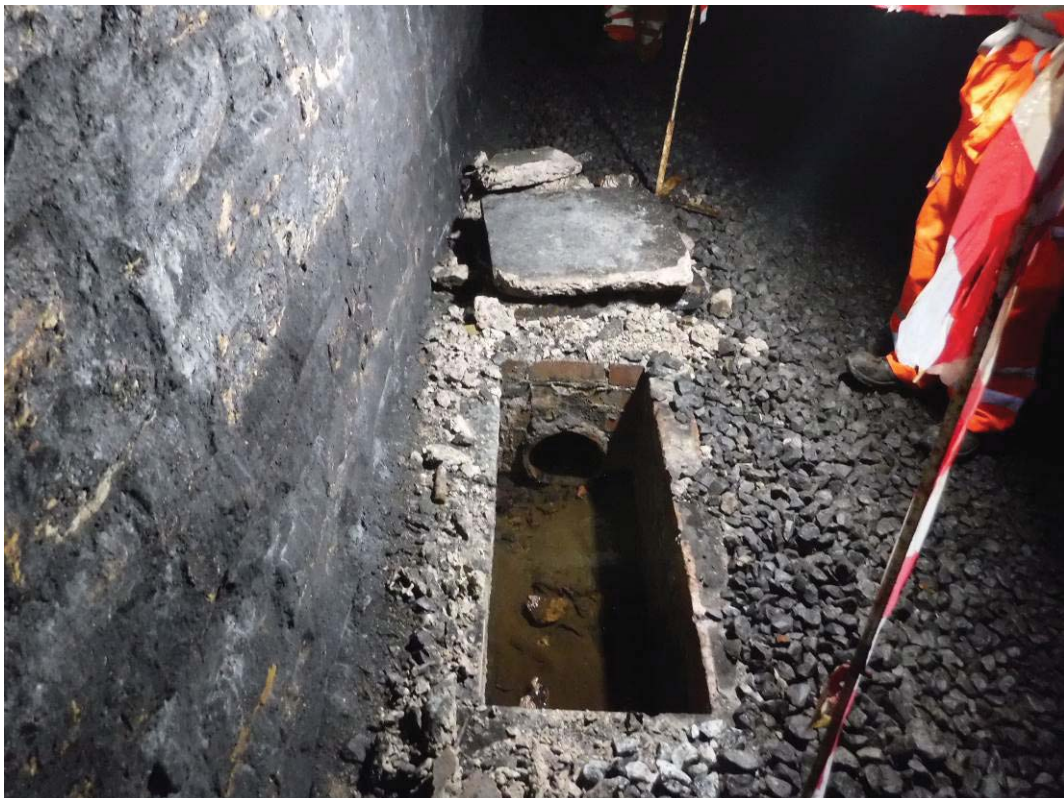
**Photo No.114:** 065+13 Cess Up, Open catch-pit.

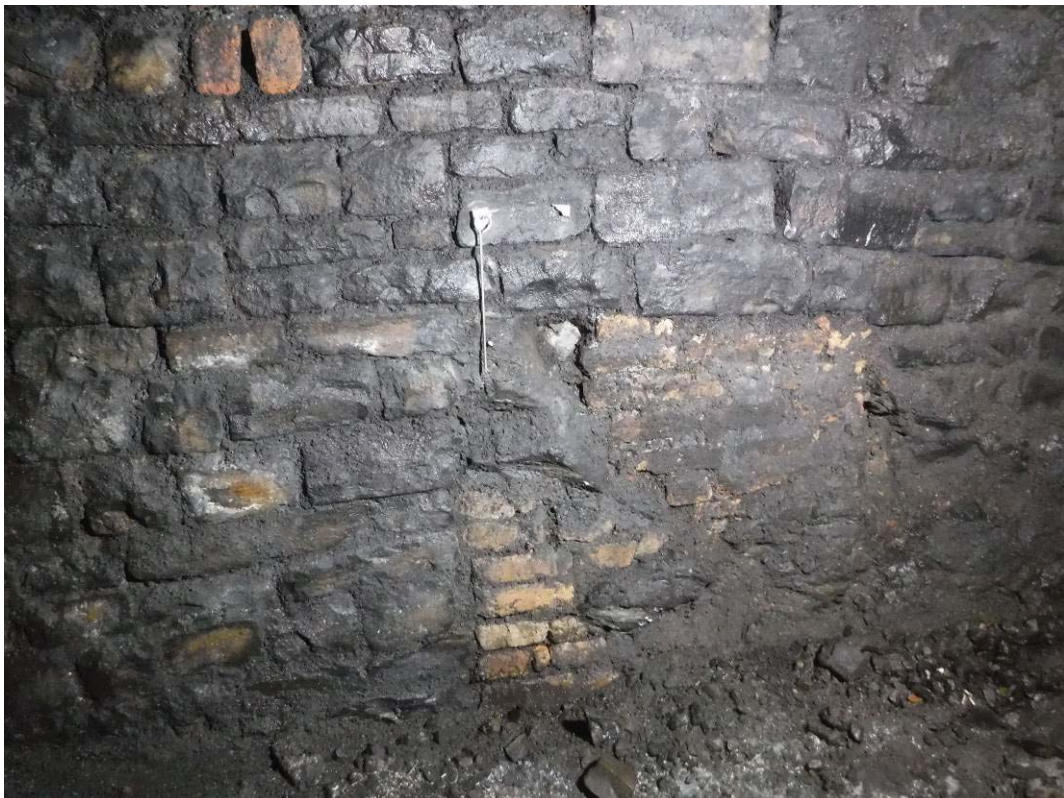
**Photo No.116:** 067+00 Sidewall Down, Tablet marker ripped off wall, remains of plate not evident on nearby solum.

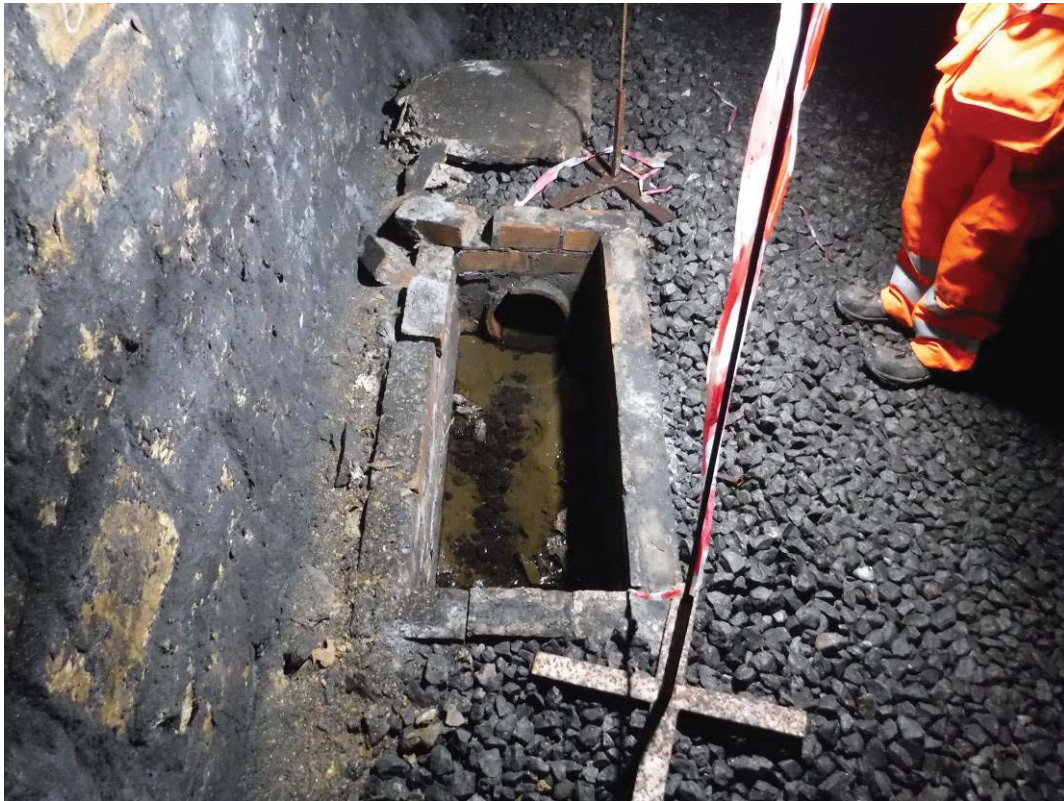
**Photo No.117:** 067+12 Cess Up, Open catch-pit.

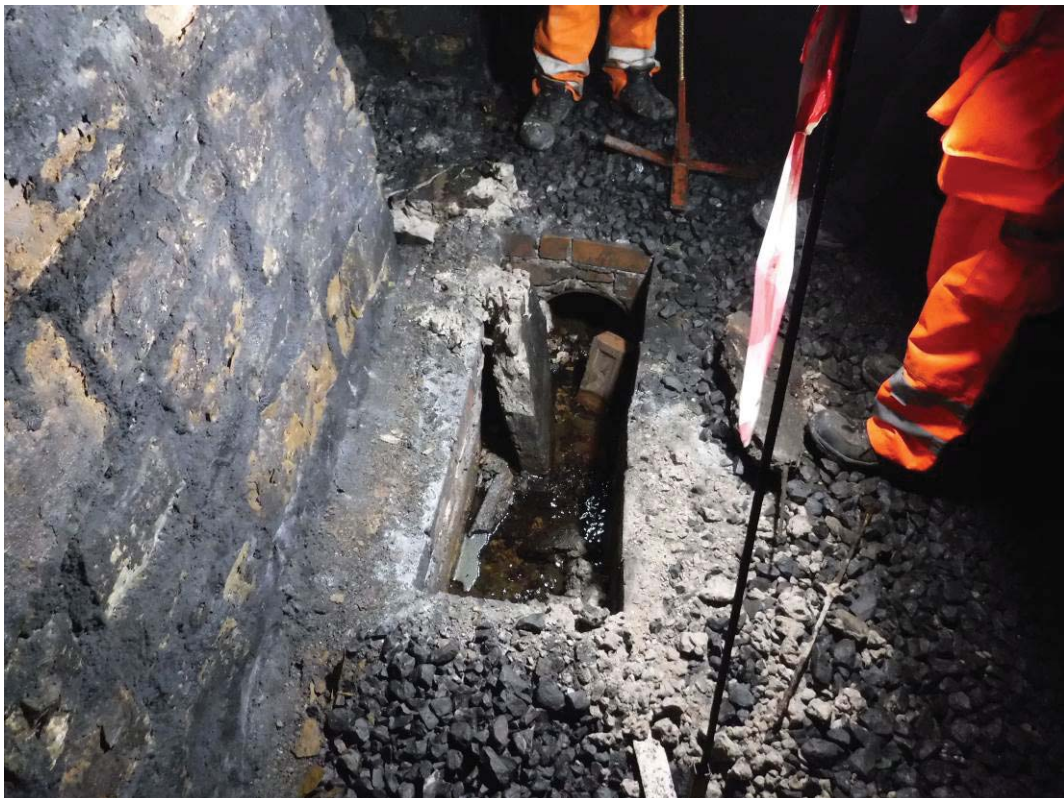
**Photo No.118:** 068+17 Cess Up, Open catch-pit.

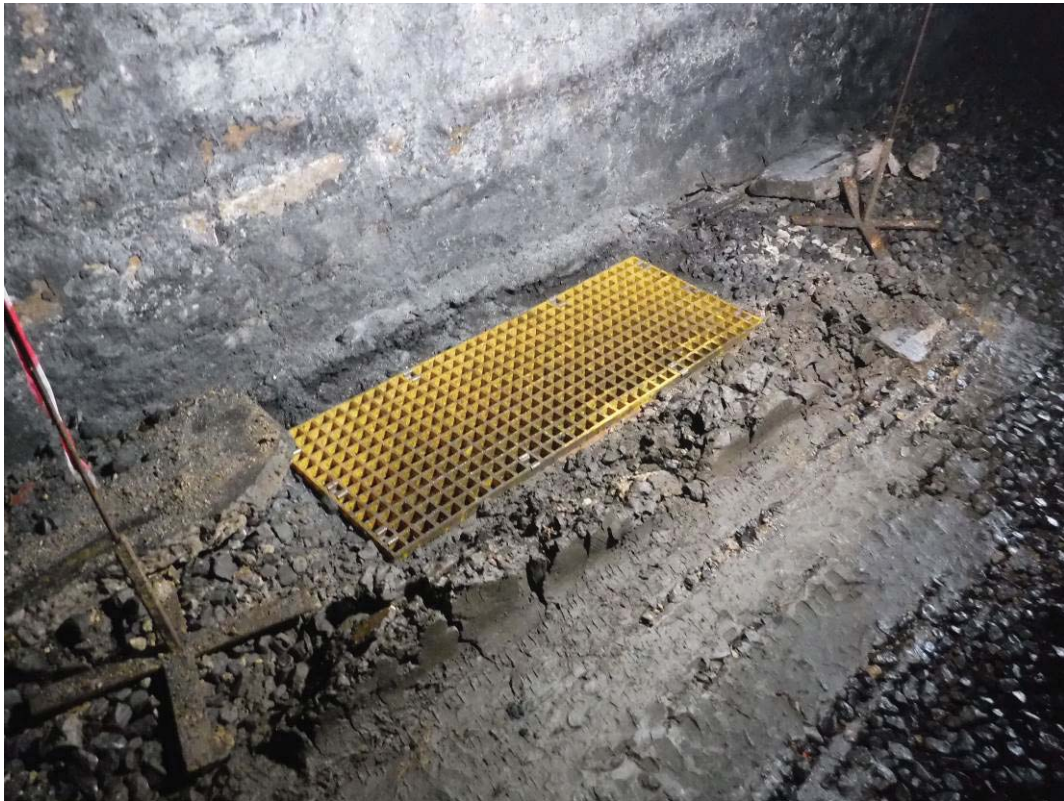
**Photo No.119:** 069+18 Cess Up, Open catch-pit. New cover fitted.
