**TUNNEL EXAMINATION REPORT  
PHOTOGRAPHS OF STRUCTURE**

ELR : MER Br. No. : 00

Mileage : 03 M 37 ch Sheet 41 of 79

<b>ELR:</b>	BLE	<b>Structure No:</b>		<b>Mileage:</b>	187m 64ch	<b>Examination date:</b>	14/11/17
<b>Route:</b>	Barnstaple Branch Line					<b>OS ref:</b>	SS 871 261
<b>Name:</b>	East Anstey Tunnel					<b>Type:</b>	Tunnel

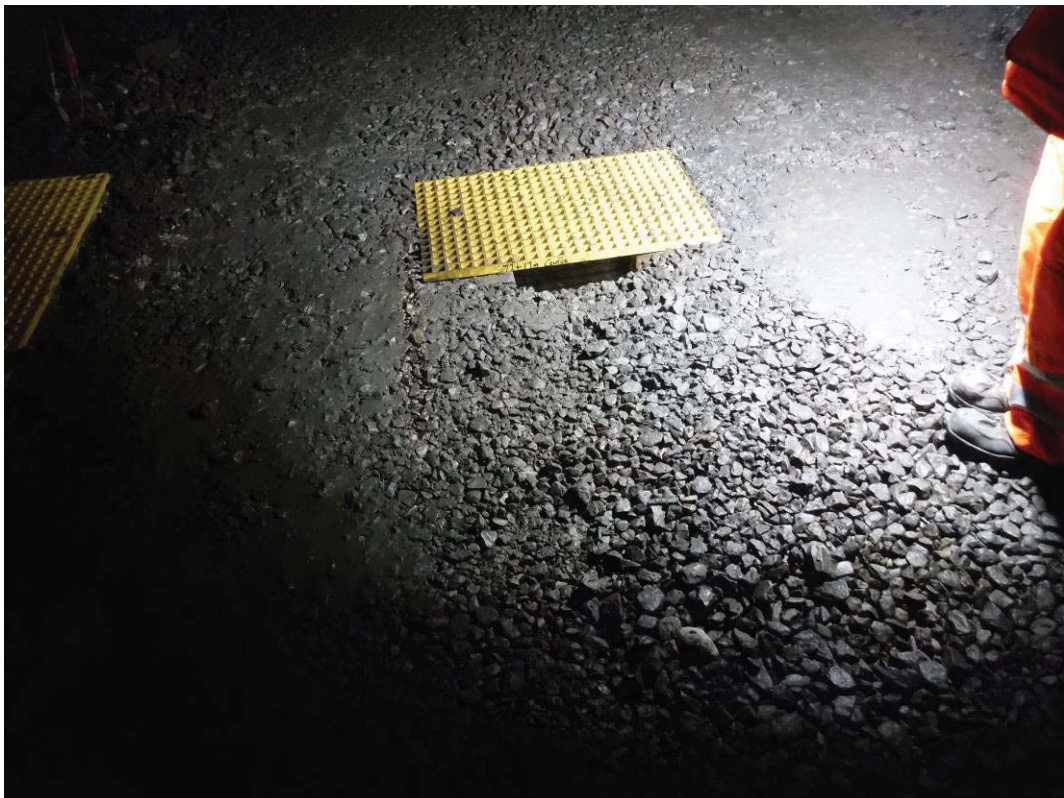
**Photo No.120:** 072+15 Cess Up, Open catch-pit. New cover fitted.

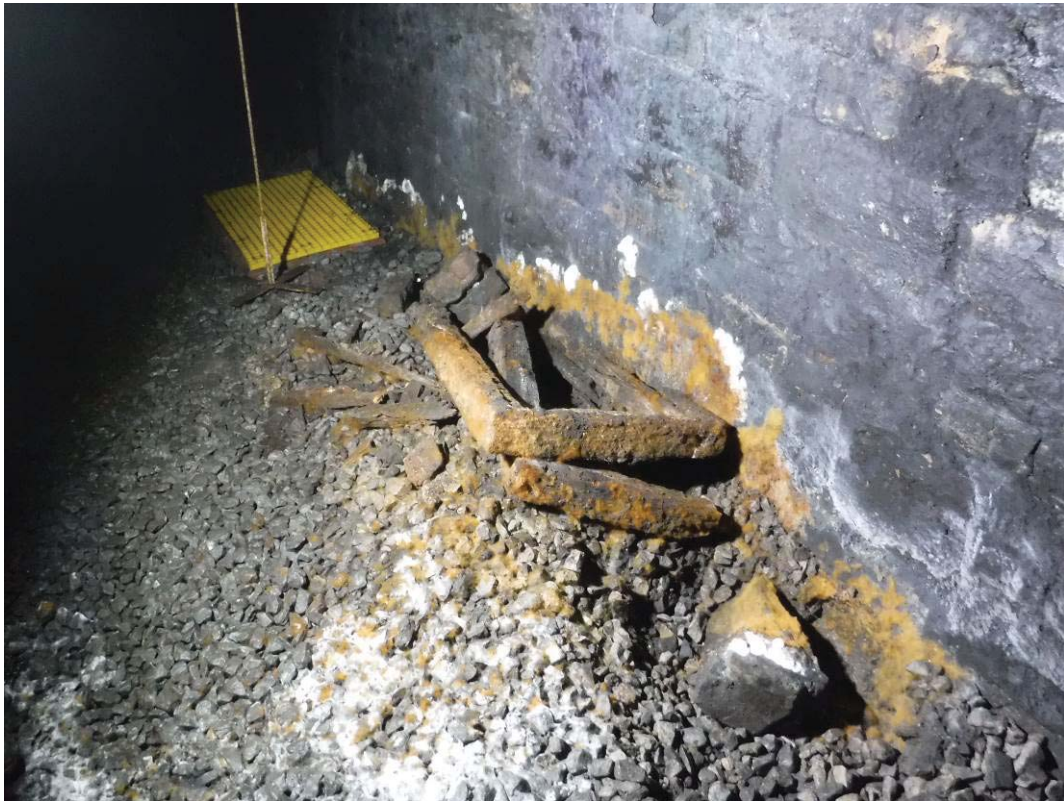
**Photo No.123:** 082+20 Cess Down, Open catch-pit.

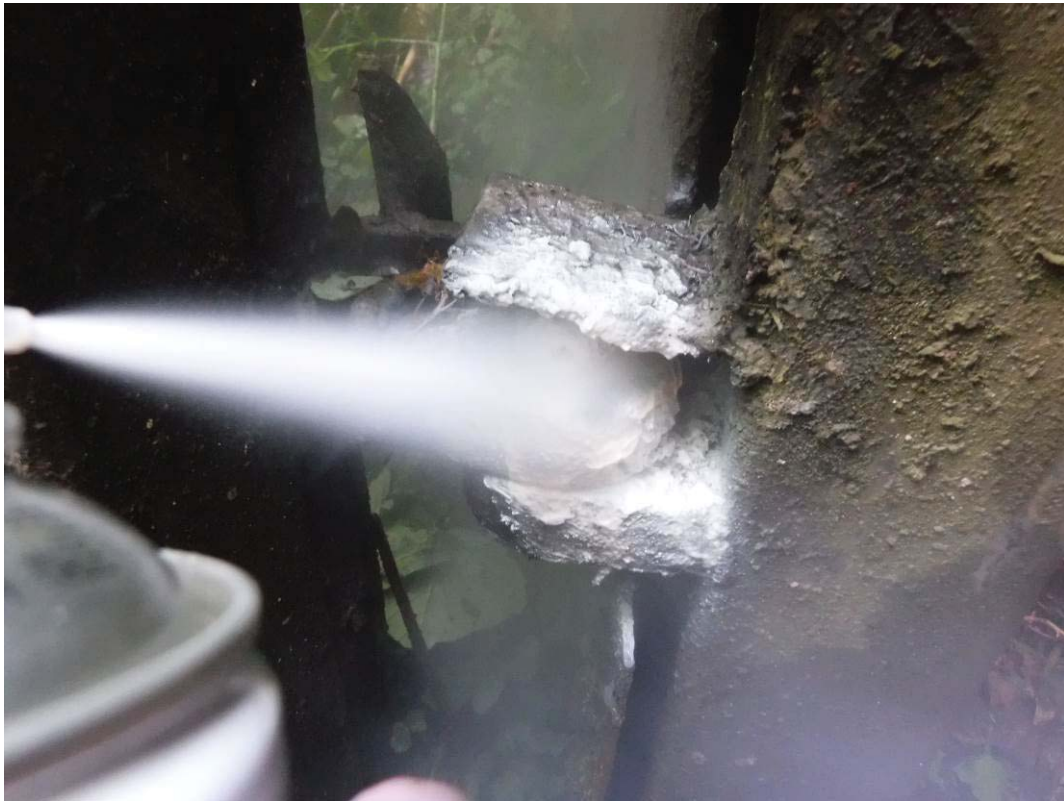
**Photo No.131:** Northeast Portal, oiling hinges.

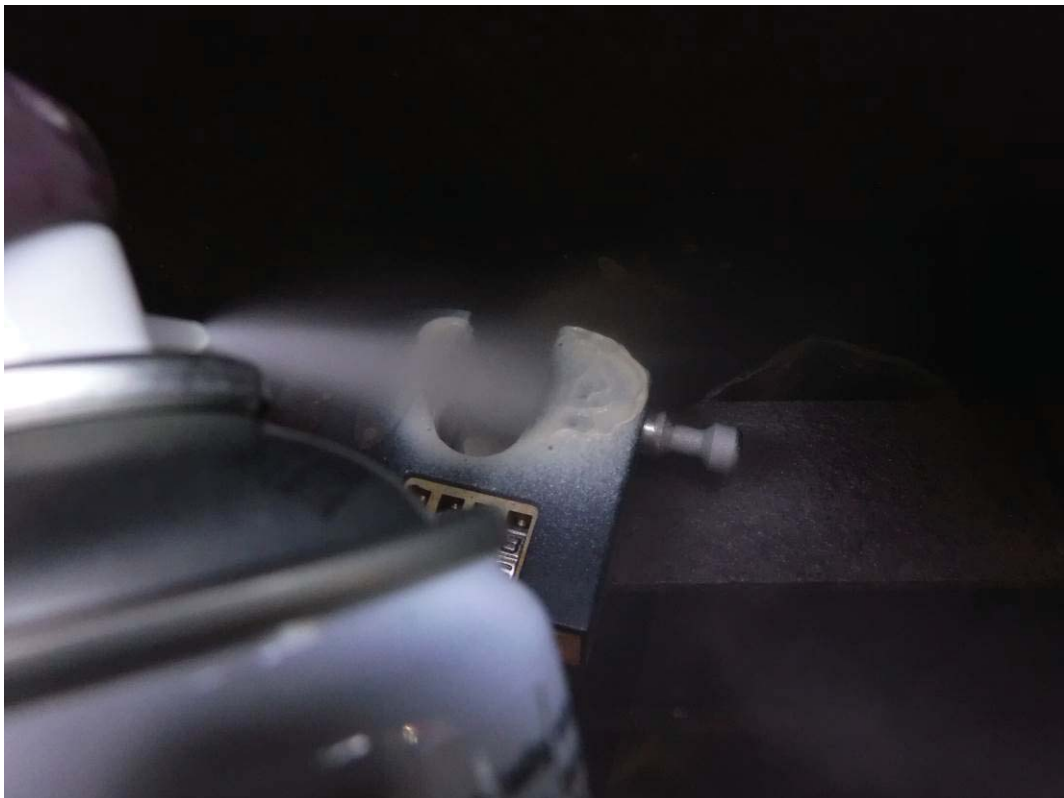
**Photo No.132:** Northeast Portal, oiling padlock.

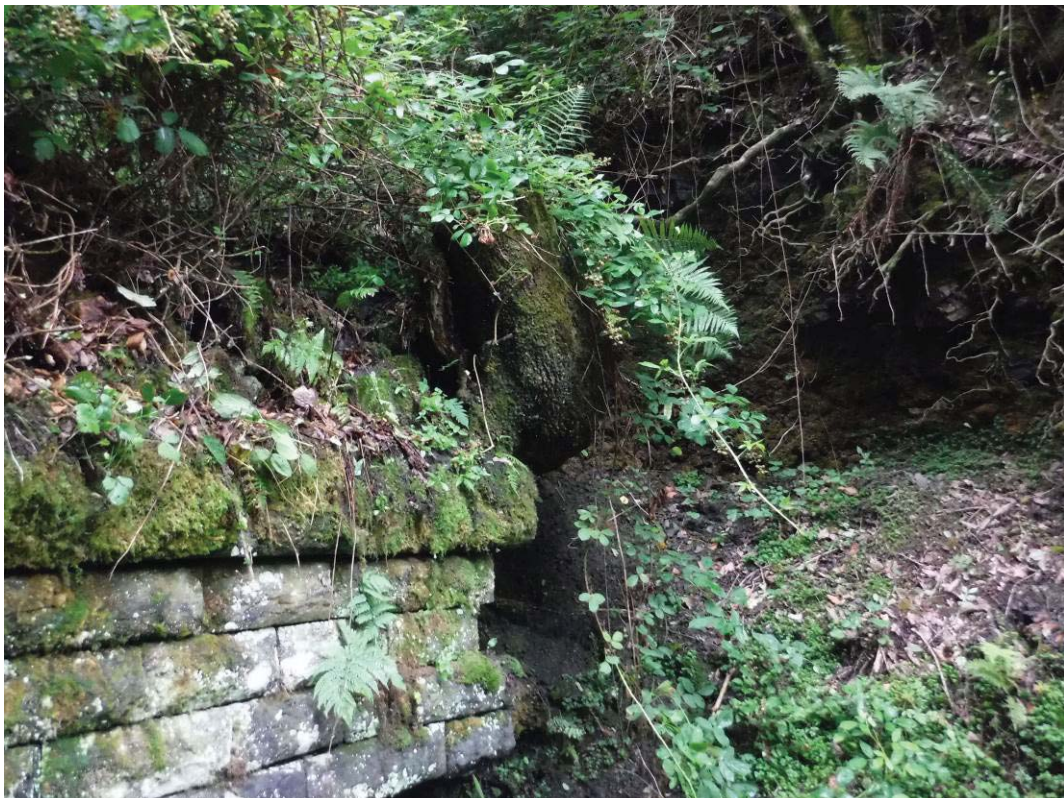
**Photo No.134:** Northeast Portal, Stonework, end of parapet, tree stump growing, girth 1.5m.

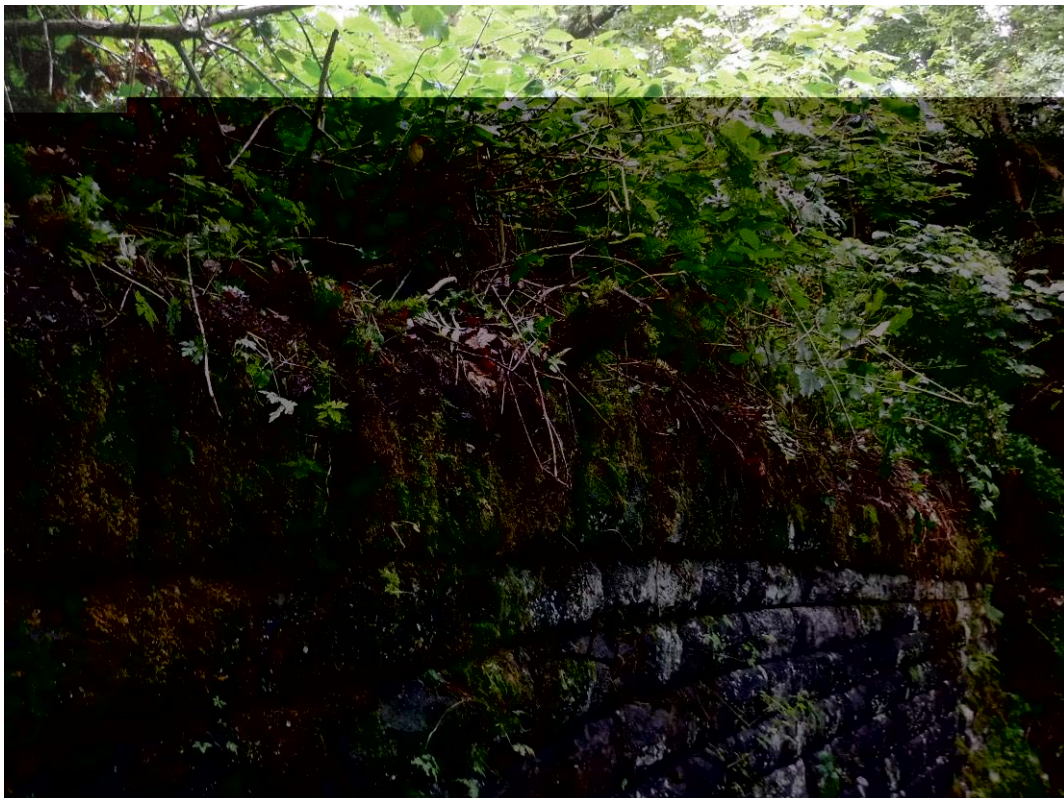
**Photo No.140:** Northeast Portal, Stonework, parapet coping pushing forward c.6". Tree stumps behind coping.

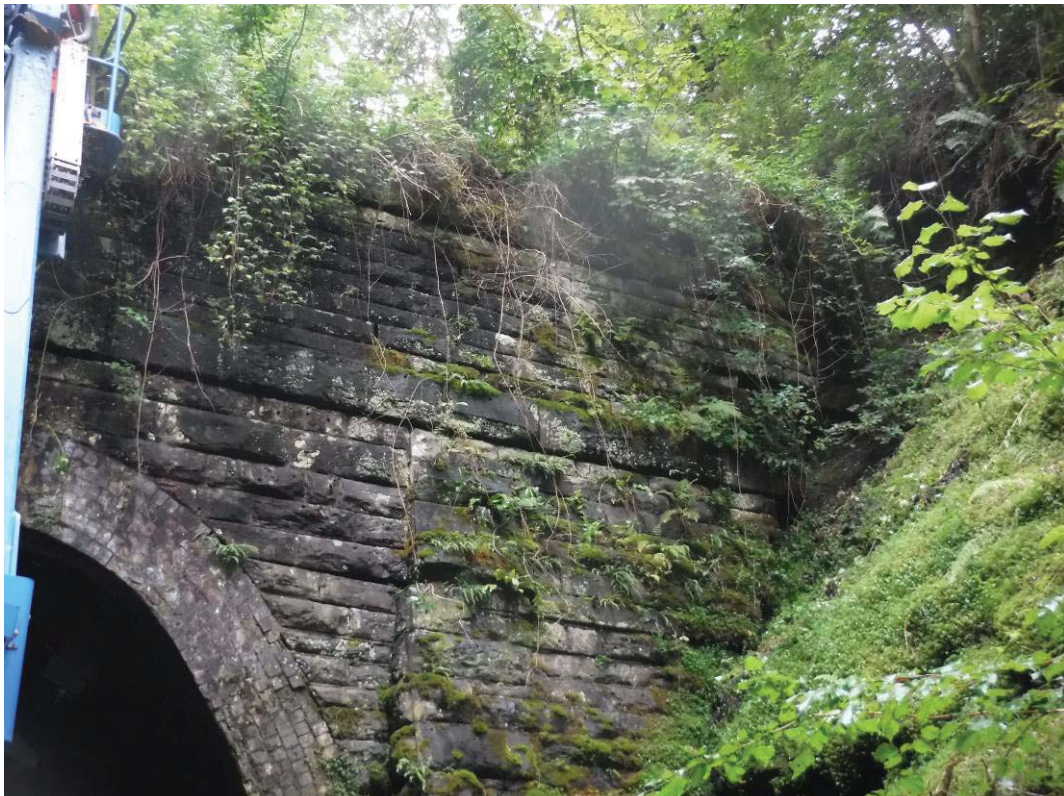
**Photo No.144:** Northeast Portal, Stonework, Vegetation. BEFORE WORKS.

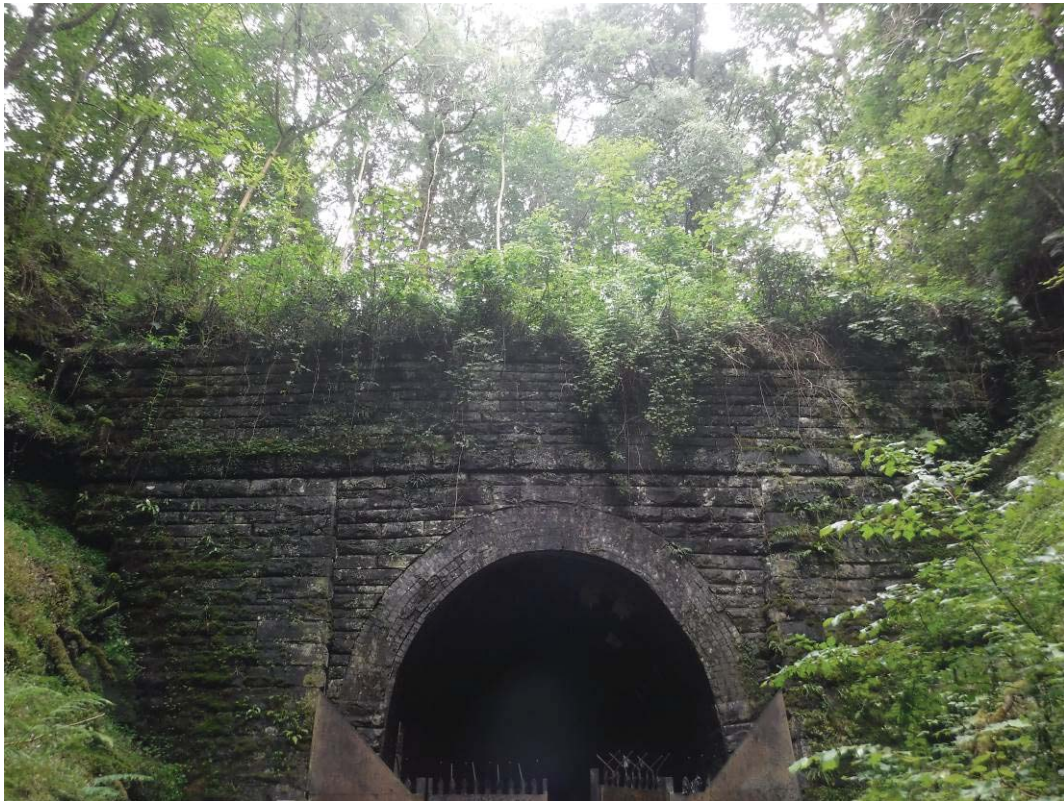
**Photo No.145:** Northeast Portal, Stonework, Vegetation. BEFORE WORKS.

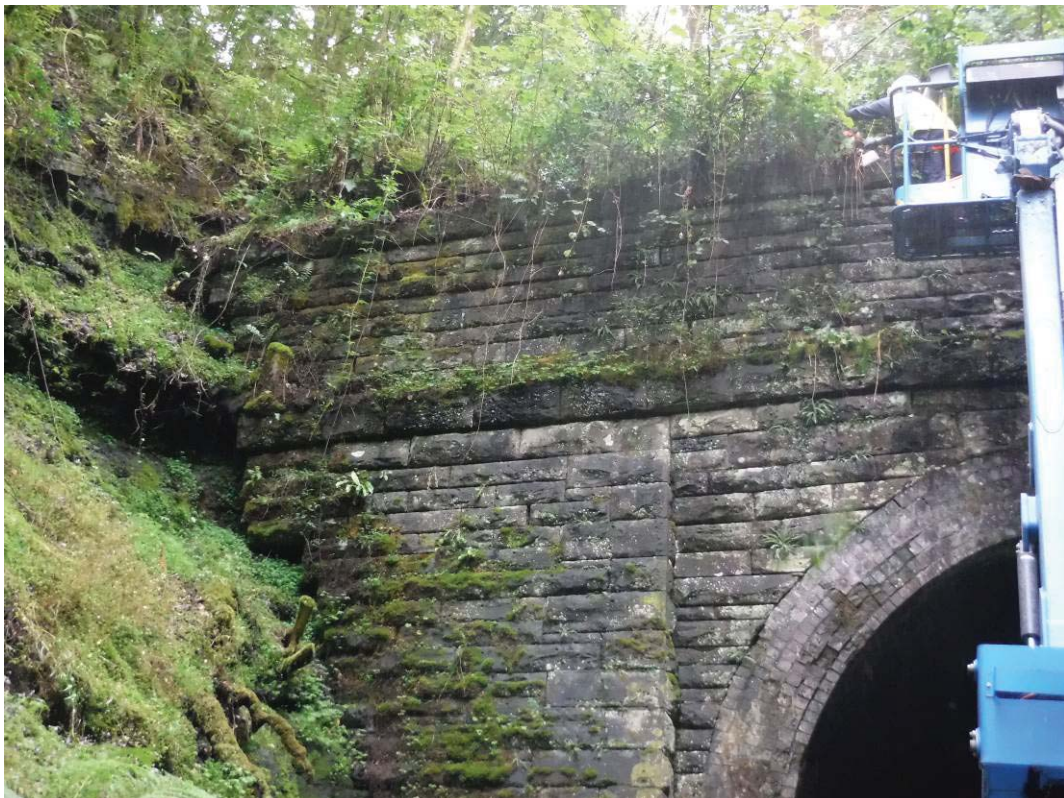
**Photo No.146:** Northeast Portal, Stonework, Vegetation. BEFORE WORKS.

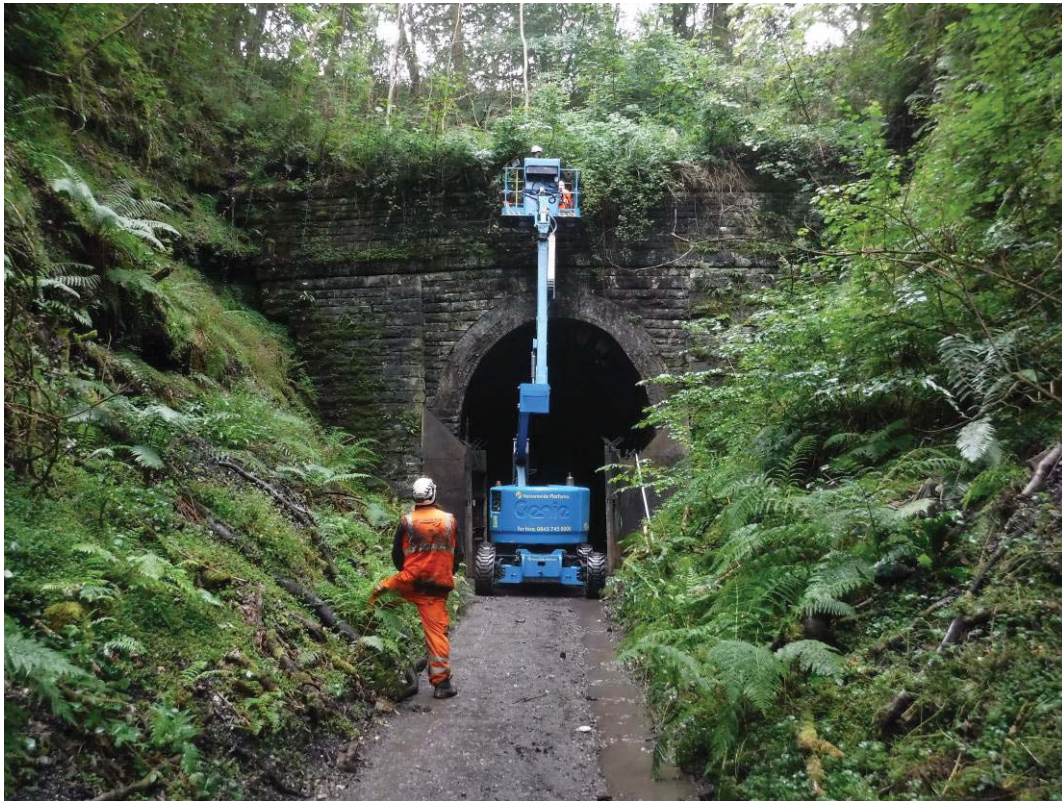
**Photo No.147:** Northeast Portal, Stonework, Vegetation. BEFORE WORKS - Ecological examination.

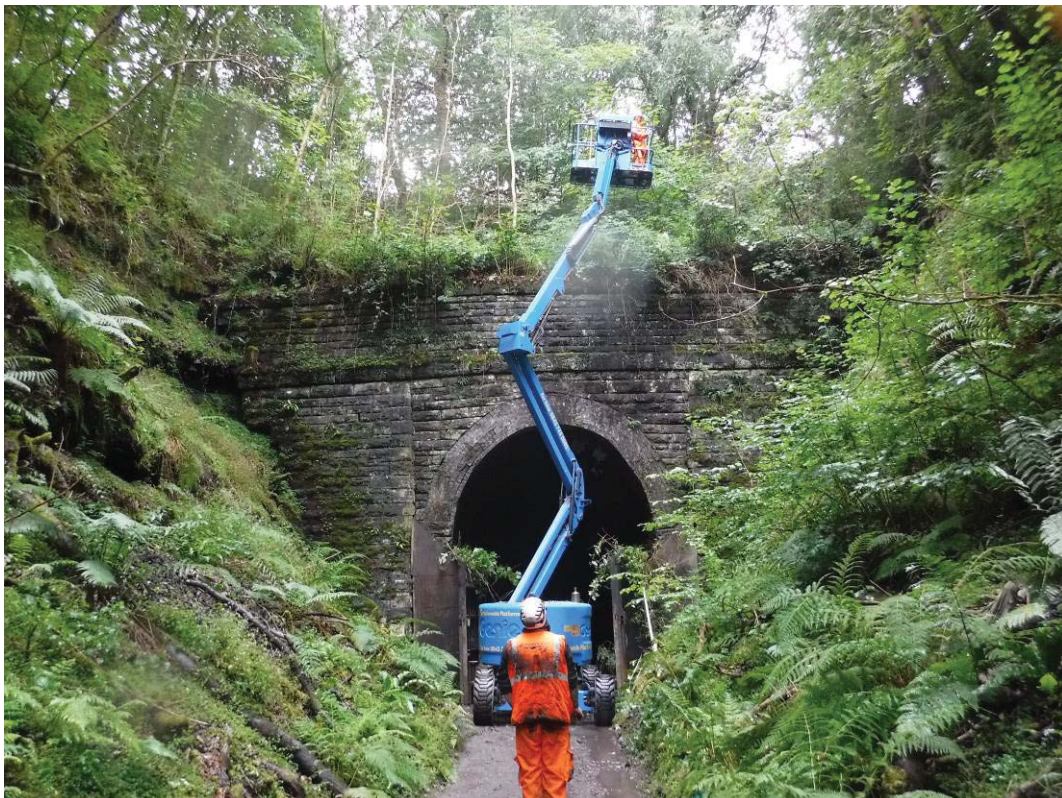
**Photo No.148:** Northeast Portal, Stonework, Vegetation. DURING WORKS - Removing vegetation.

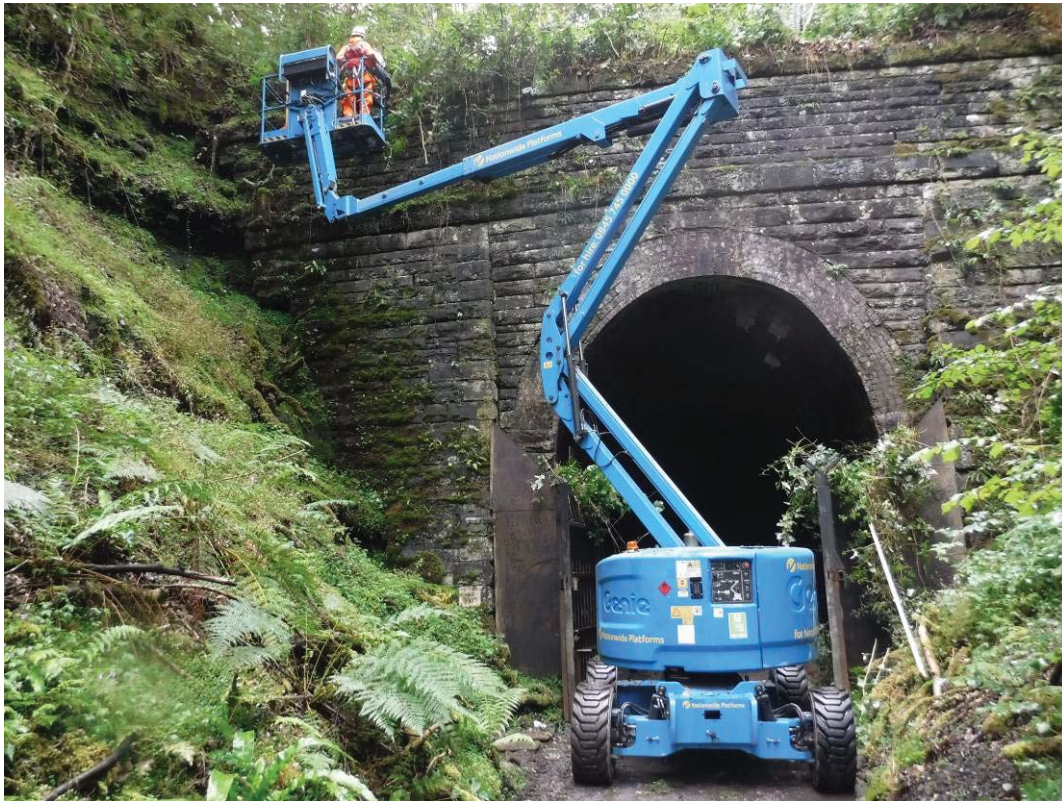
**Photo No.149:** Northeast Portal, Stonework, Vegetation. DURING WORKS - Removing vegetation.

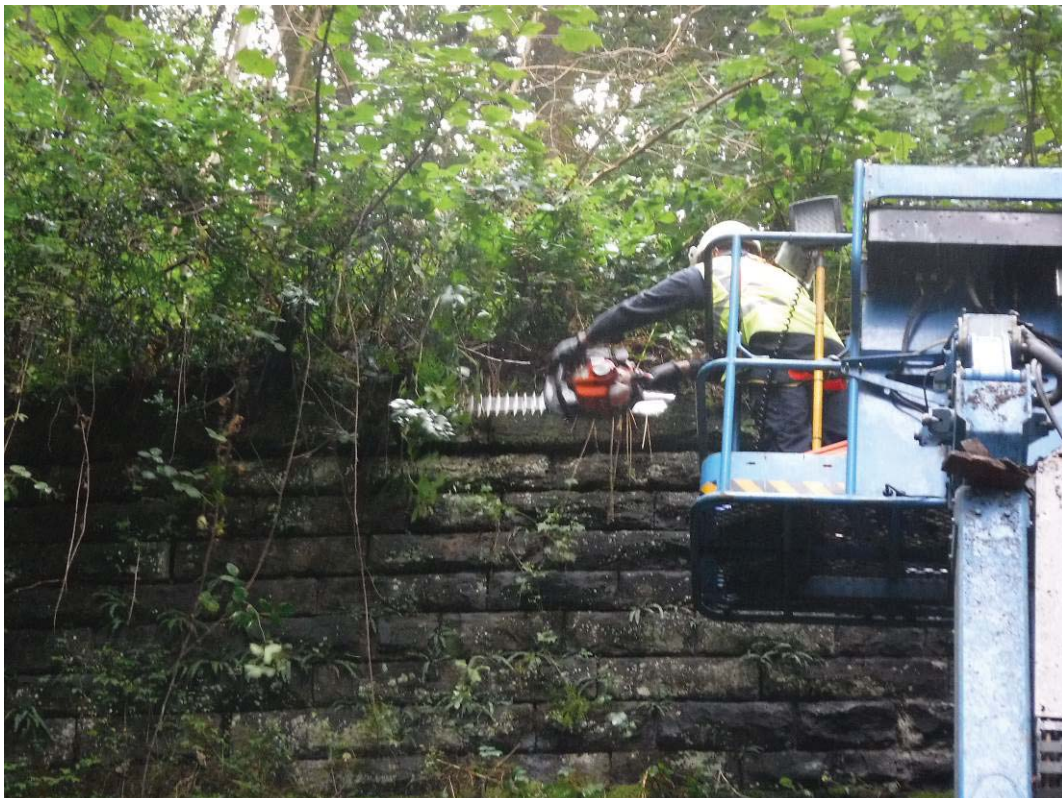
**Photo No.150:** Northeast Portal, Stonework, Vegetation. DURING WORKS - Removing vegetation.

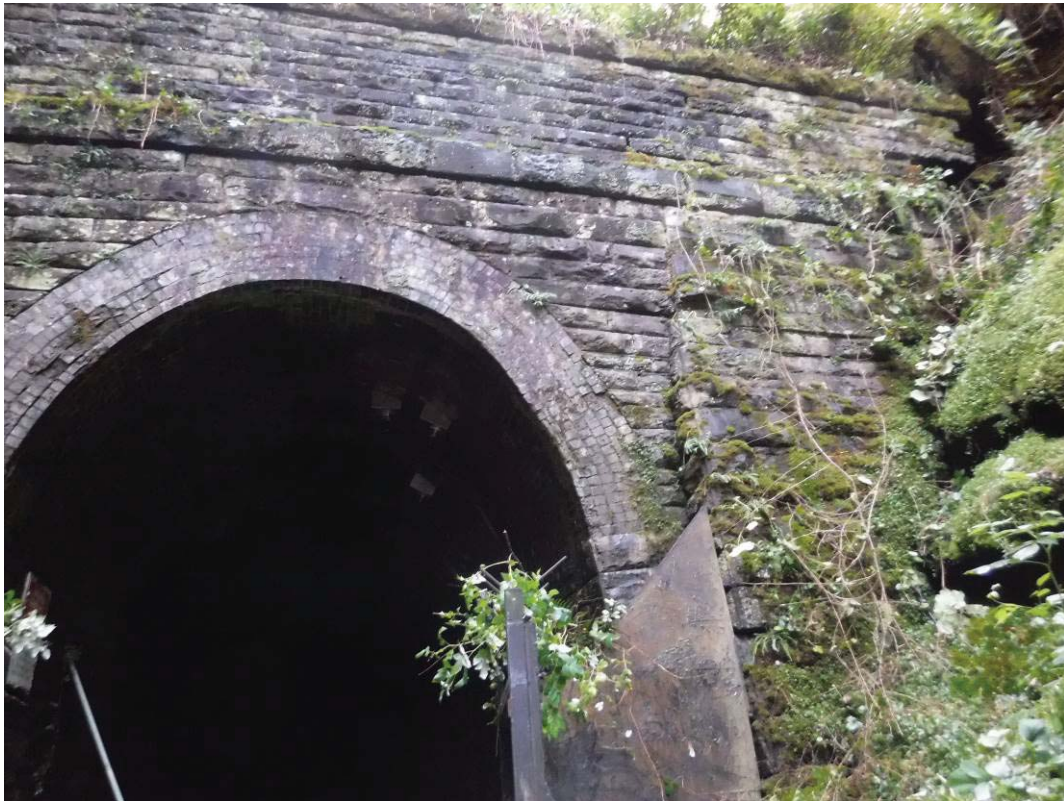
**Photo No.151:** Northeast Portal, Stonework, Vegetation. AFTER WORKS - only moss & lichens remain on stonework.

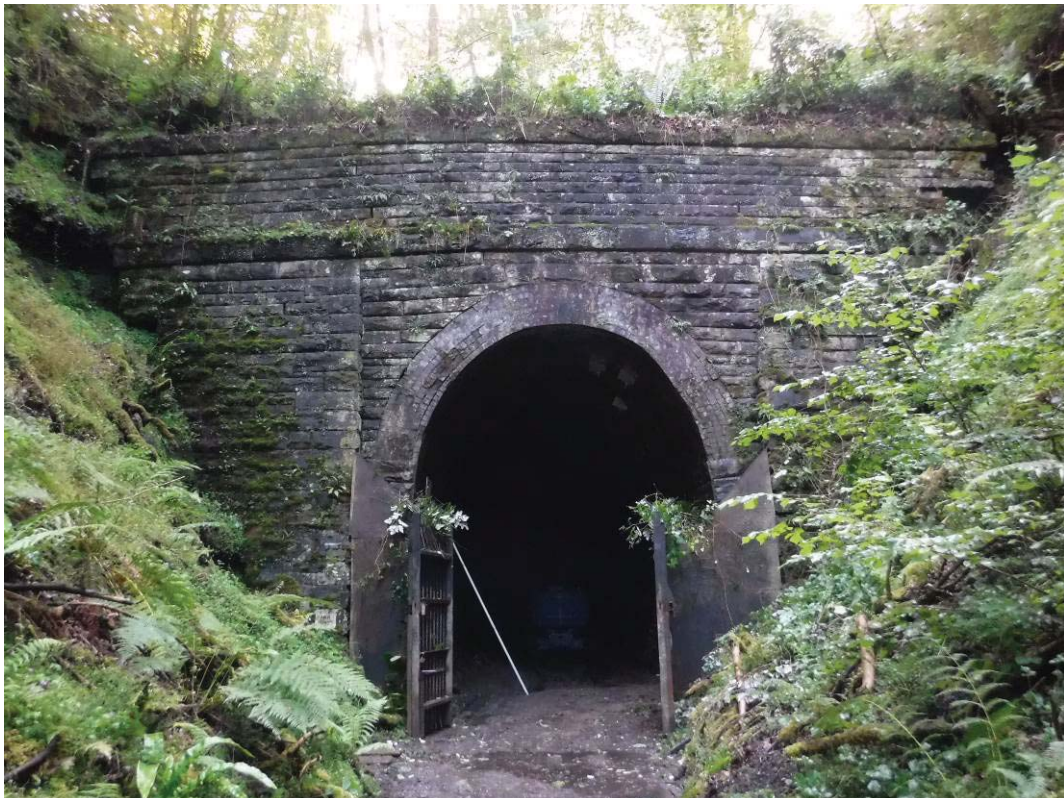
**Photo No.152:** Northeast Portal, Stonework, Vegetation. AFTER WORKS - only moss & lichens remain on stonework.

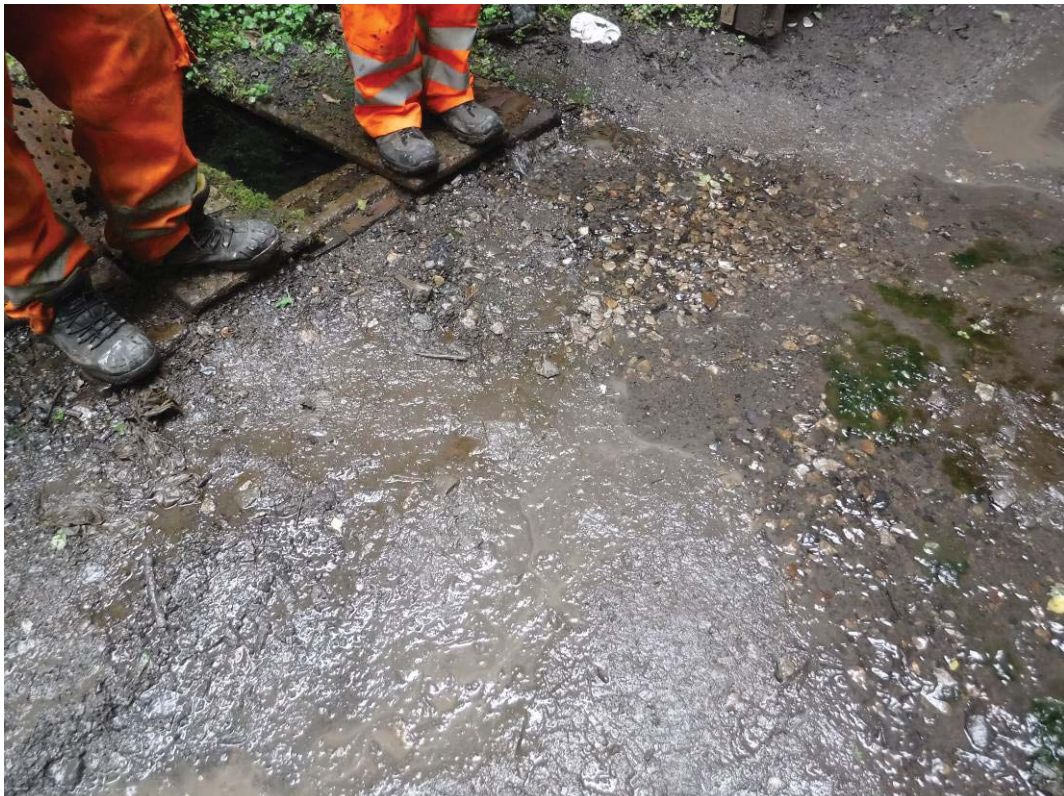
**Photo No.154:** 114+05 Cess Down, Catch-pit blocked and water surcharging onto solum. Stream flows to NE along upside cess.

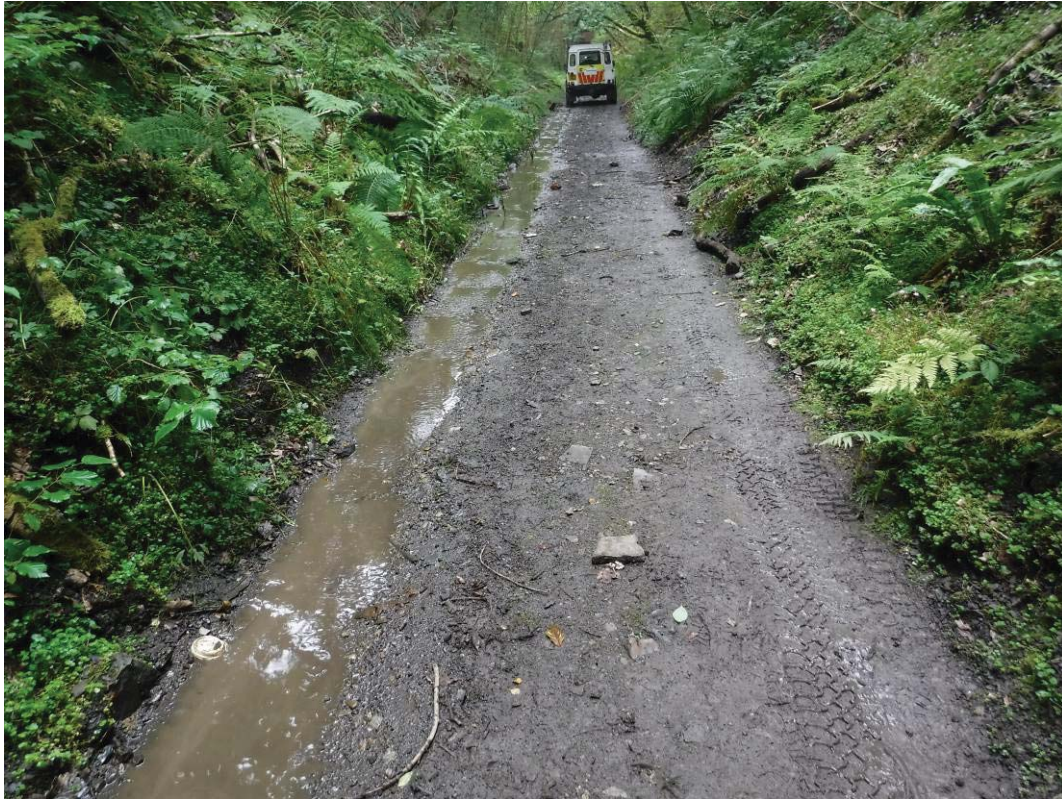
**Photo No.155:** 114+05 Cess Down, Catch-pit blocked and water surcharging onto solum. Stream flows to NE along upside cess.

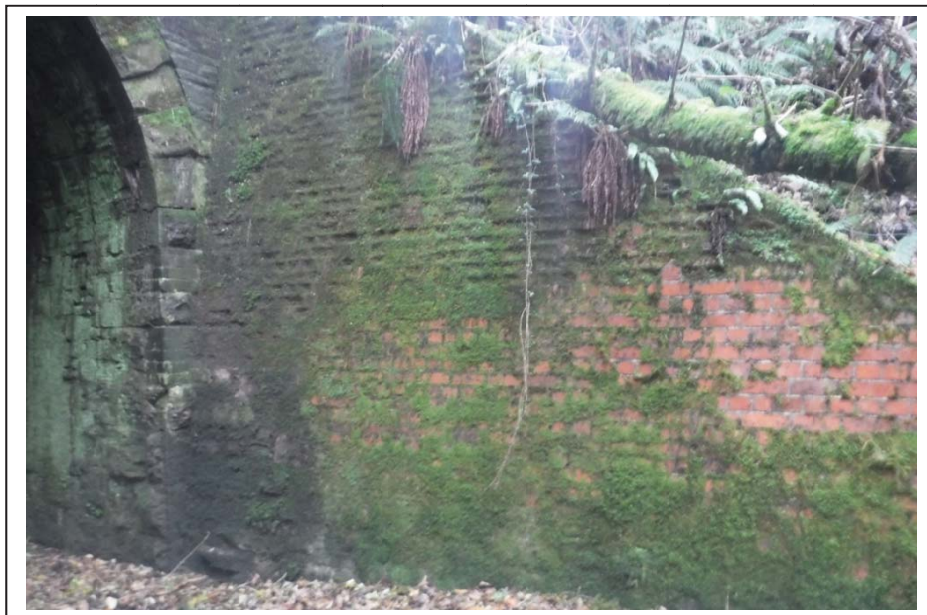
Photograph no 1: DC wingwall

Notes	
<p><b>East Anstey Tunnel</b> <b>BLE 187m 64ch</b></p> <p><b>Country end East Anstey portal</b></p> <p><b>Downside wingwall (P1)</b> Moss coverage to <b>60%</b> of the wingwall with some light vegetation cover. Patches removed for examination Hollow sounding area 600mm<sup>2</sup> at centre of lower third, 2m above GL. Widespread long-standing spalling up to 30mm deep over 5m<sup>2</sup> in the upper half of the wingwall (mainly moss covered) (<b>P2</b>).</p>	
<p><b>Headwall</b> Moss coverage to 65% of the headwall. Vertical fracture to headwall above crown open 2mm displaced <b>20mm (P6)</b>. Previously noted F3 in bed joint 450mm below coping visible at Downside end, now largely obscured by vegetation (<b>P7</b>) 5mm vertical fracture through masonry units in quoin of sidewall remains below U/S spandrel (<b>P9</b>). <b>F3mm</b> in first voussoir above US springing level extends into soffit of arch barrel (<b>P10</b>). Previously noted F1mm x 750mm separation fracture between U/S spandrel and voussoir extending into the mitre below springing level - overgrown with moss. Horizontal fracture one course below DS stringer, 1.2m long, open 5mm and pushing 10mm (<b>P24</b>) Lower three courses of D/S spandrel repaired in 2012. Third voussoir above D/S springing level is found spalled 50mm. Open joints to DS spandrel to 20mm (<b>P8</b>)</p>

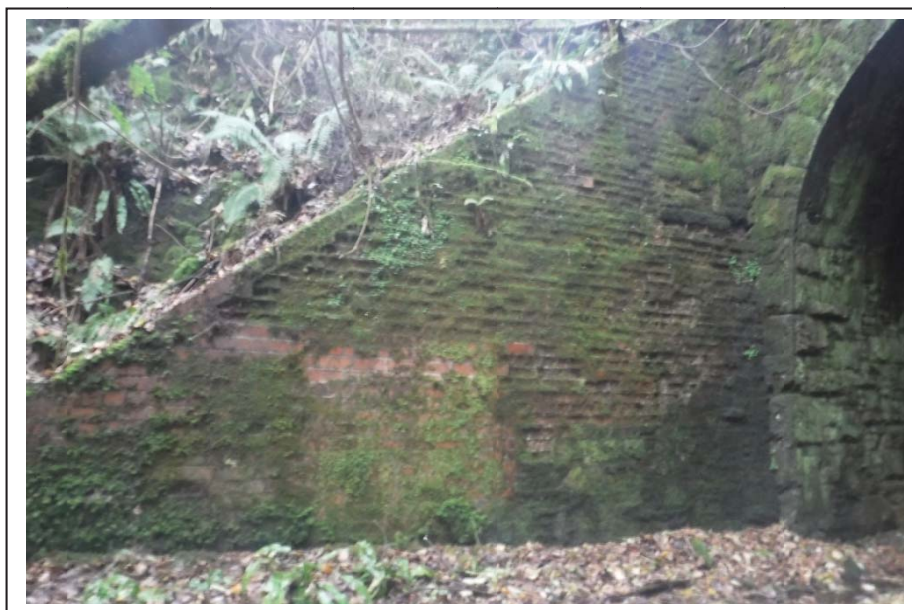
Photograph no 3: UC wingwall

<p><b>Upside Wingwall (P3)</b> Widespread spalling up to 30mm throughout affecting <b>70%</b> of the wingwall. Minor increases noted to patches Localised areas of spalling up to 100mm adjacent to mitre; total area affected approximately 0.5m<sup>2</sup> (<b>P4</b>). Single unit removed (<b>P5</b>); remainder firm to hammer.</p>
