ELR:	BLE	Structure No:	Mileage: 187m 64ch	Examination date: 14/11/17
Route:	Barnstaple Branch Line			OS ref: SS 871 261
Name:	East Anstey Tunnel			Type: Tunnel

ELR:	BOK1	Structure No:	283	Mileage:		Examination date:	26/03/19
Route:	Broad Street to Dalston West Junction					OS ref:	TQ 336 847
Name:	Dalston Lane					Type:	Tunnel

Balfour Beatty Rail, Manchester
Bridgnorth Tunnel
ELR:SVB/43
Examined:29/11/2018

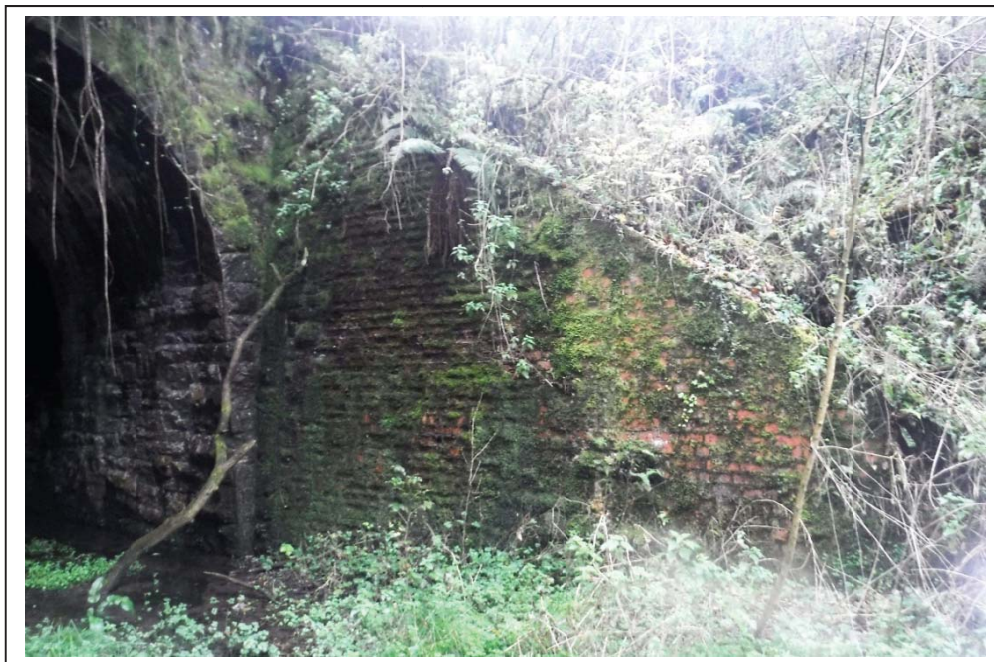
Photograph no 17: UL wingwall

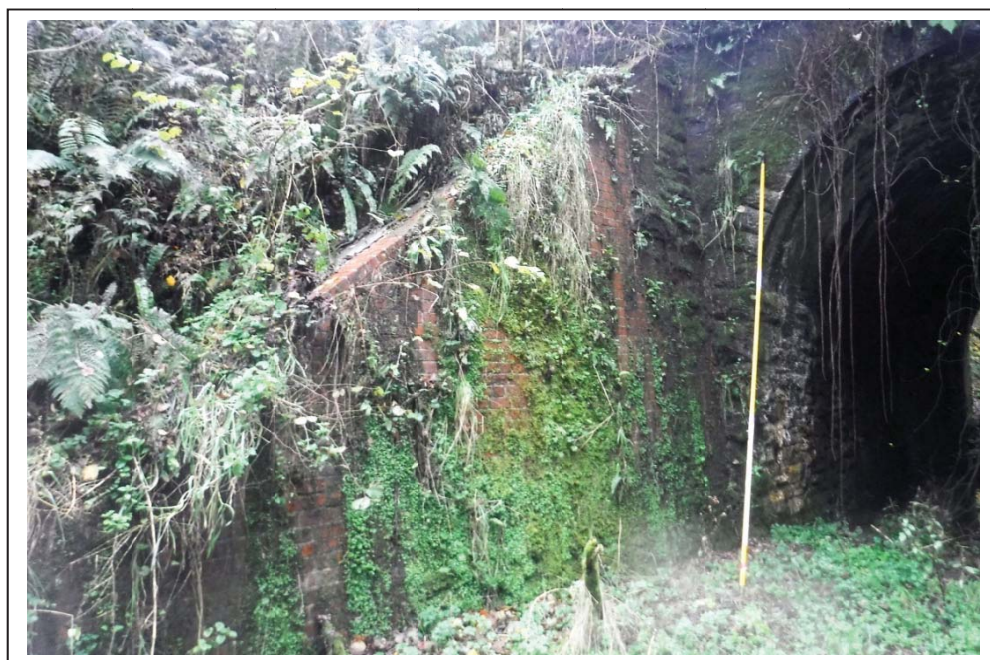
Photograph no 18: DL wingwall

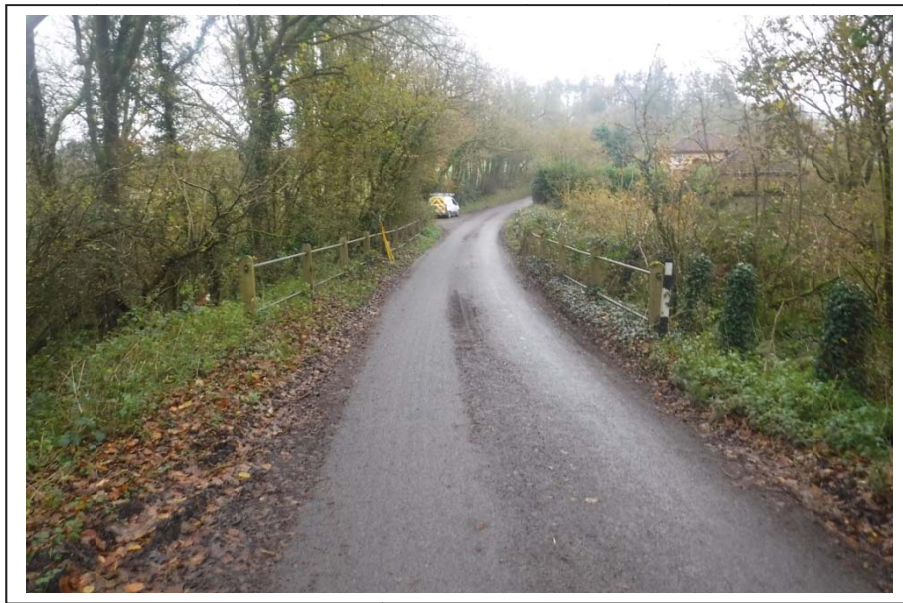
Photograph no 25: The structure carries the single unclassified carriageway “Oldway Road”

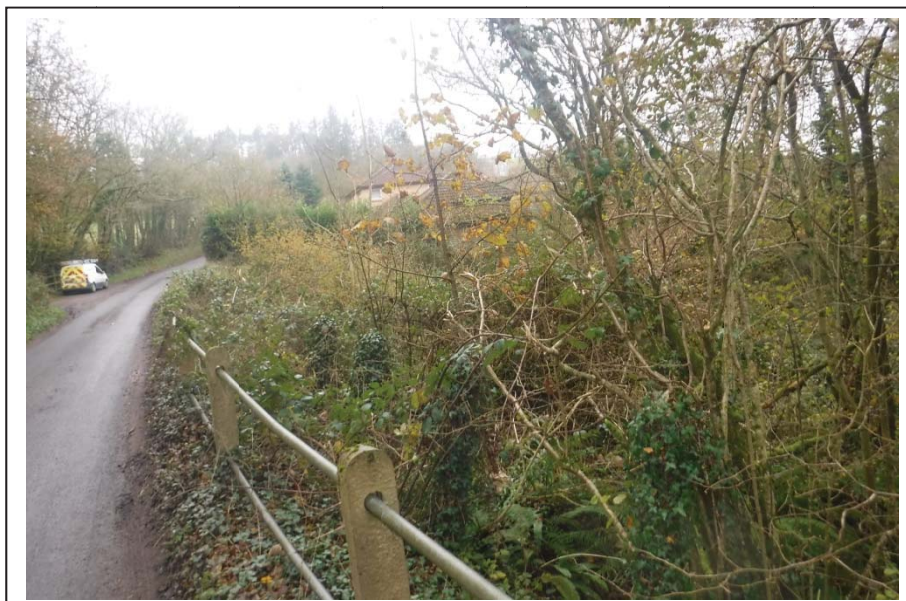
Photograph no 26: Roadside fencing to rear of LE portal below

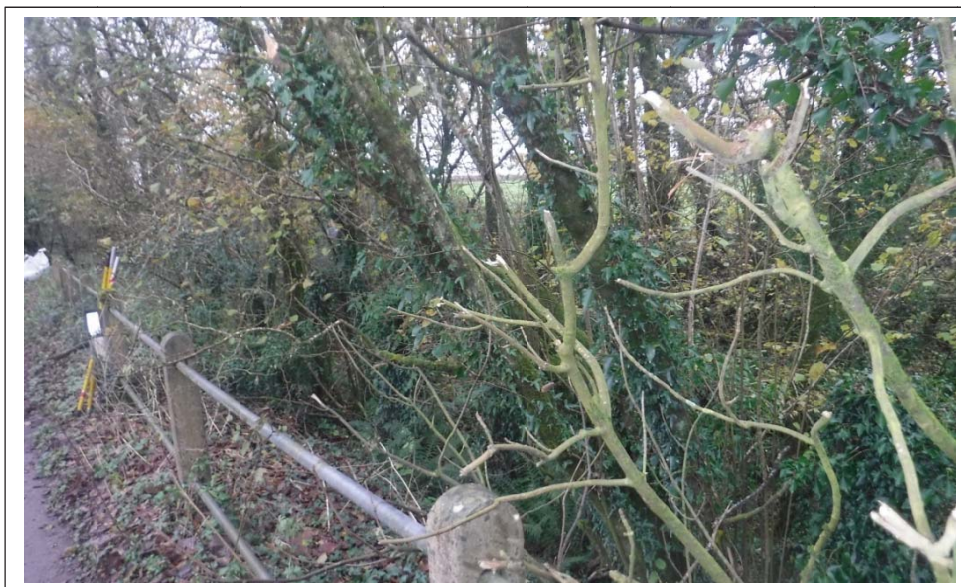
Photograph no 27: Roadside fencing to rear of CE portal below

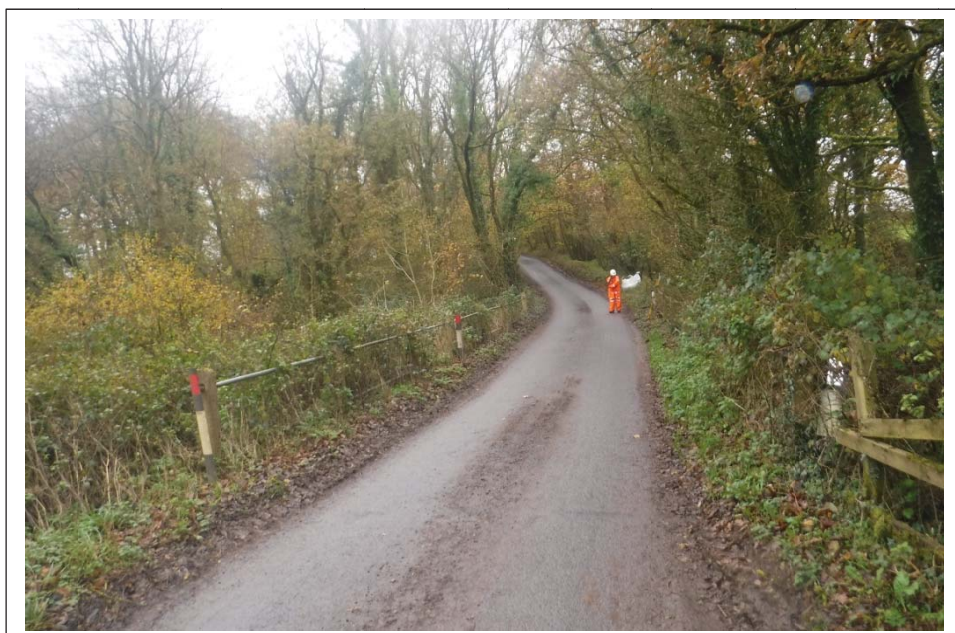
Photograph no 28: The structure carries the single unclassified carriageway "Oldway Road"

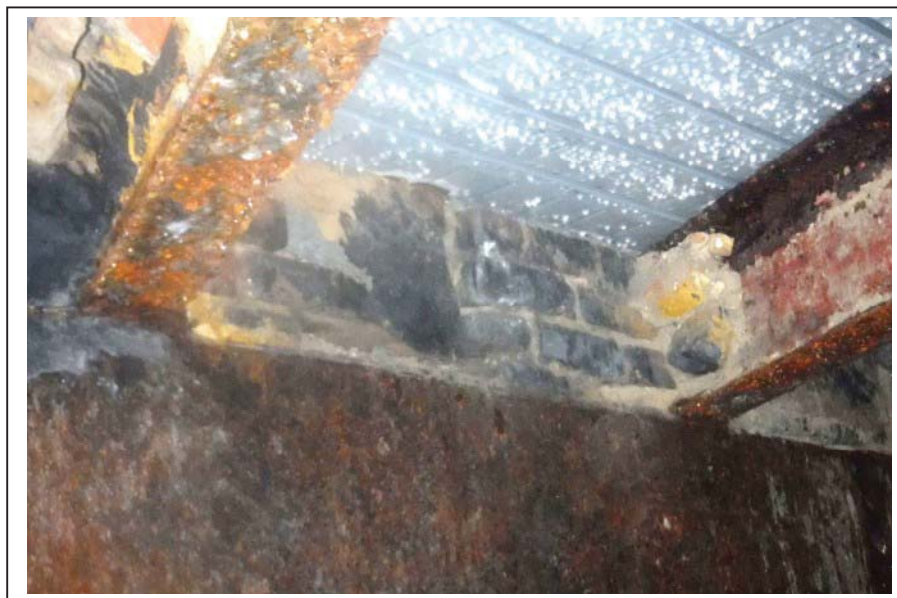
Photograph no 3: Cross girders 6 and 7 and main girder 2 facing towards DL

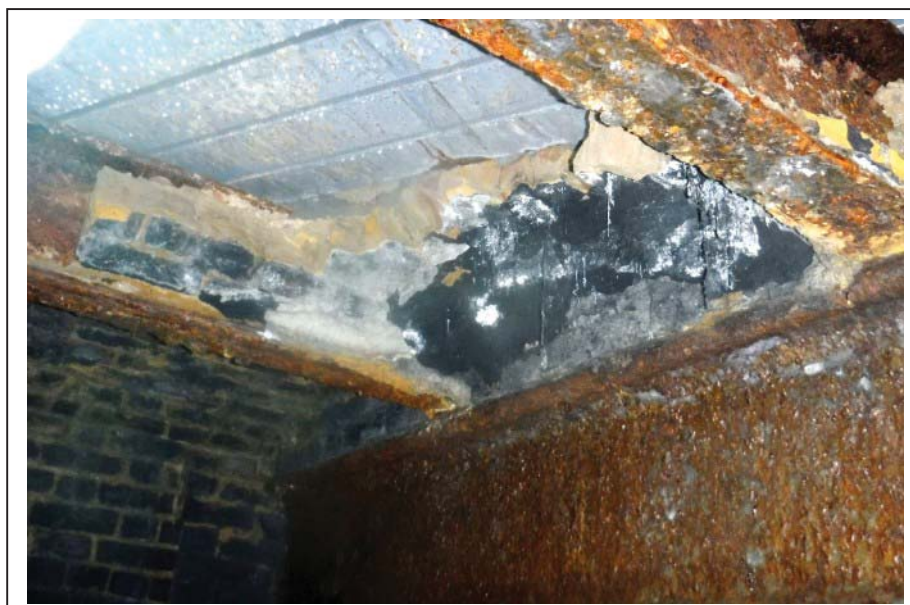
Girder No3: metal beam (510mm deep, 410wide). Moderate surface corrosion to all exposed faces. Girder found wet throughout (P5): surface corrosion removed in places for examination.

Photograph no 4: remainder of jack arch with wet main girder 3 to rear

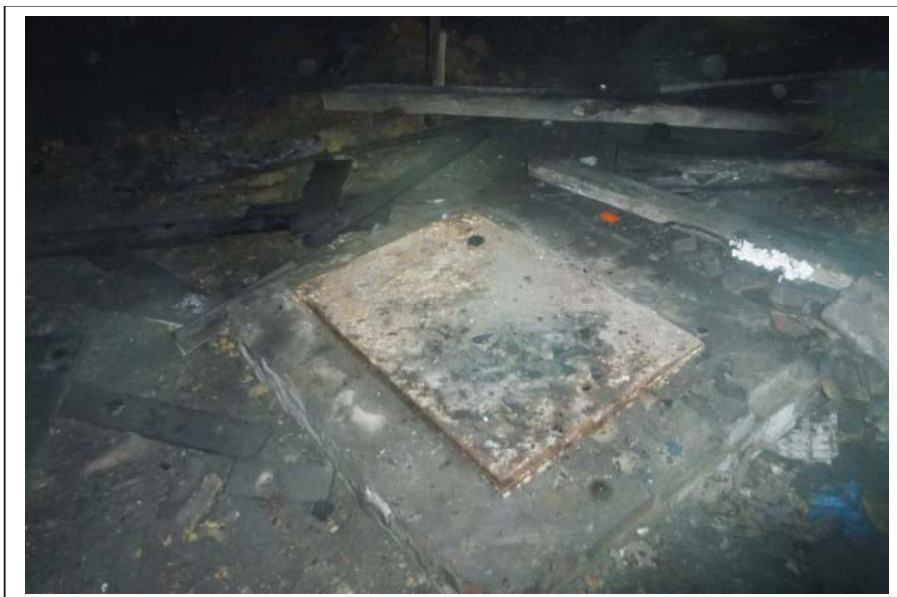
Photograph no.45: Manhole cover 7m to LE of girder 8 remains in place
Foul smell emanating from area locally

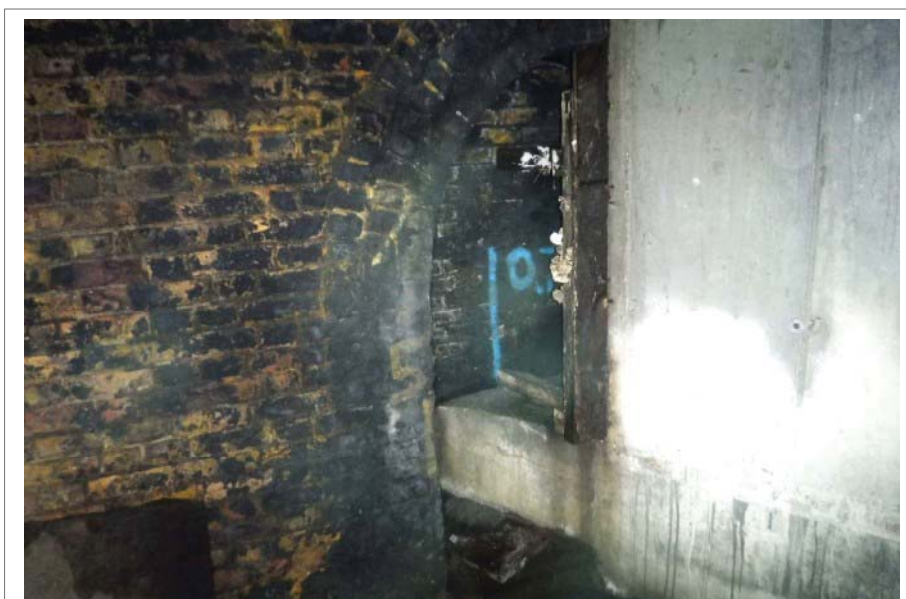
Photograph no.46: Refuge 1 (below US girder 7): partially infilled by new concrete wall support

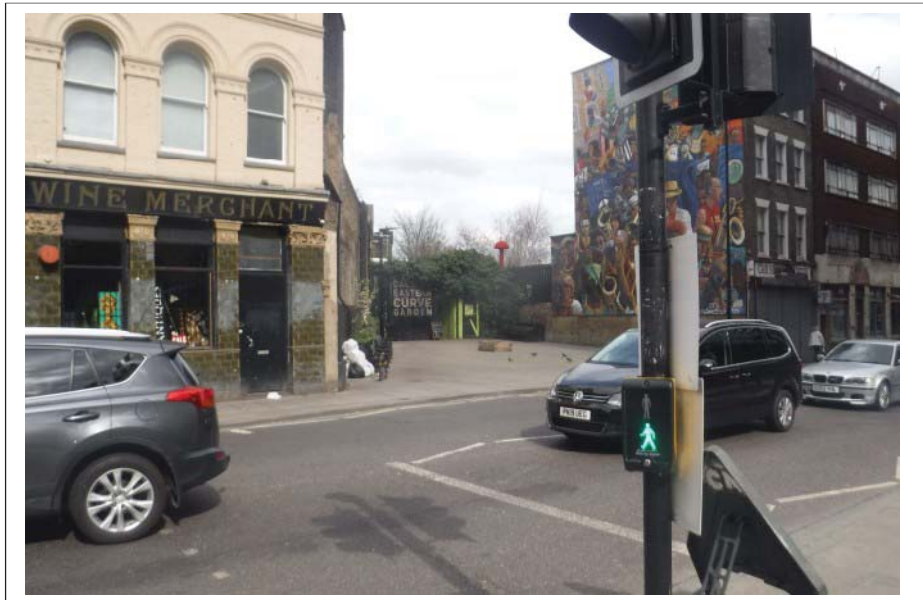
Photograph no.47: View towards CE portal along tunnel line
