**TUNNEL EXAMINATION REPORT
PHOTOGRAPHS OF STRUCTURE**

Balfour Beatty Rail, Manchester**Caerau (Cymmer) Tunnel****ELR: BAL/10m17ch****Examined: 05/02/2019**

Balfour Beatty Rail, Manchester**Pen-Cae-Drain Tunnel****ELR: VON/28m 65ch****Examined: 30/07/2019**

Balfour Beatty Rail, Manchester
Penar Tunnel
ELR:HRD2/4m 42ch Examined:14/10/2019

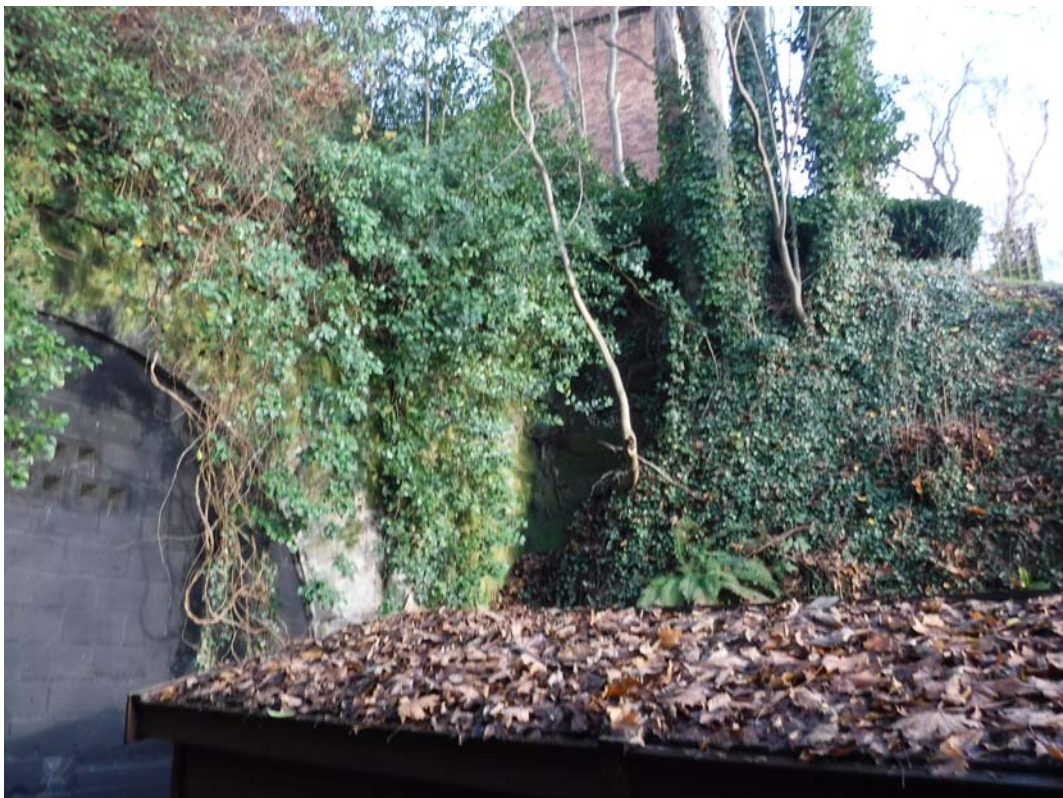
Photo No. 4 : 000+00 Portal Full Profile Up & Down, Bridgnorth Portal, Stonework, overgrown with vegetation and saplings, area 50sq.m.

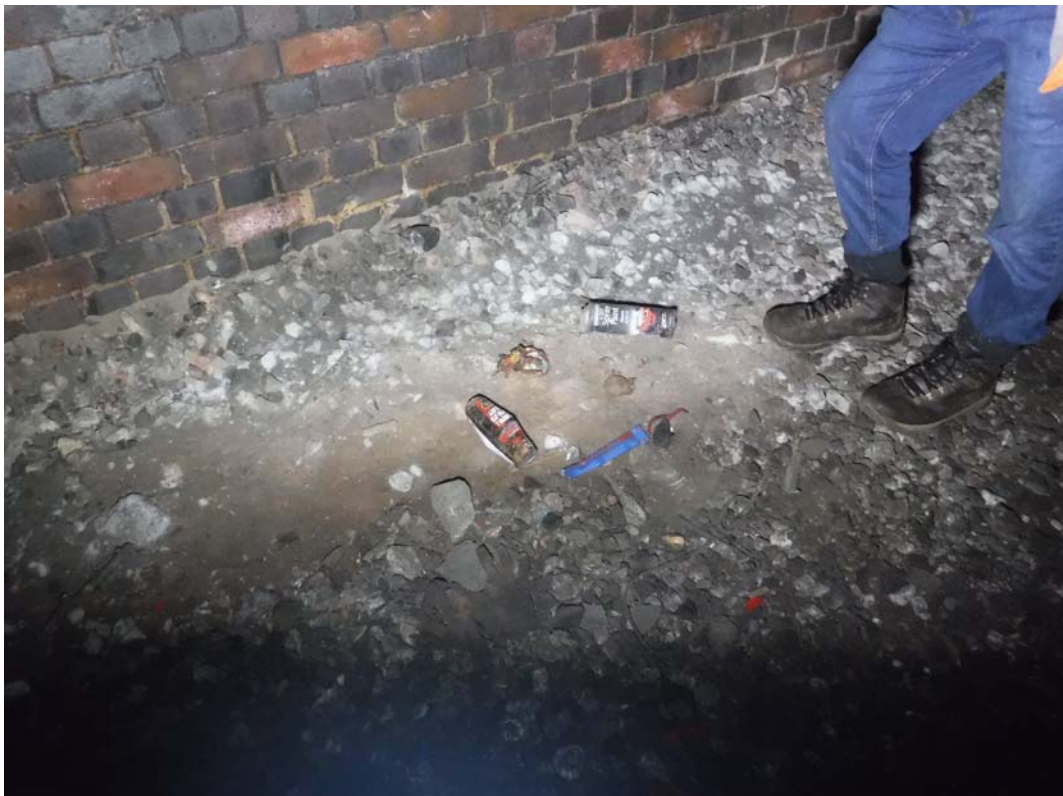
Photo No. 8 : 000+00 to 025+11 Solum Up & Down, Typical views showing recent example of paint cans, pens and litter left in the tunnel.

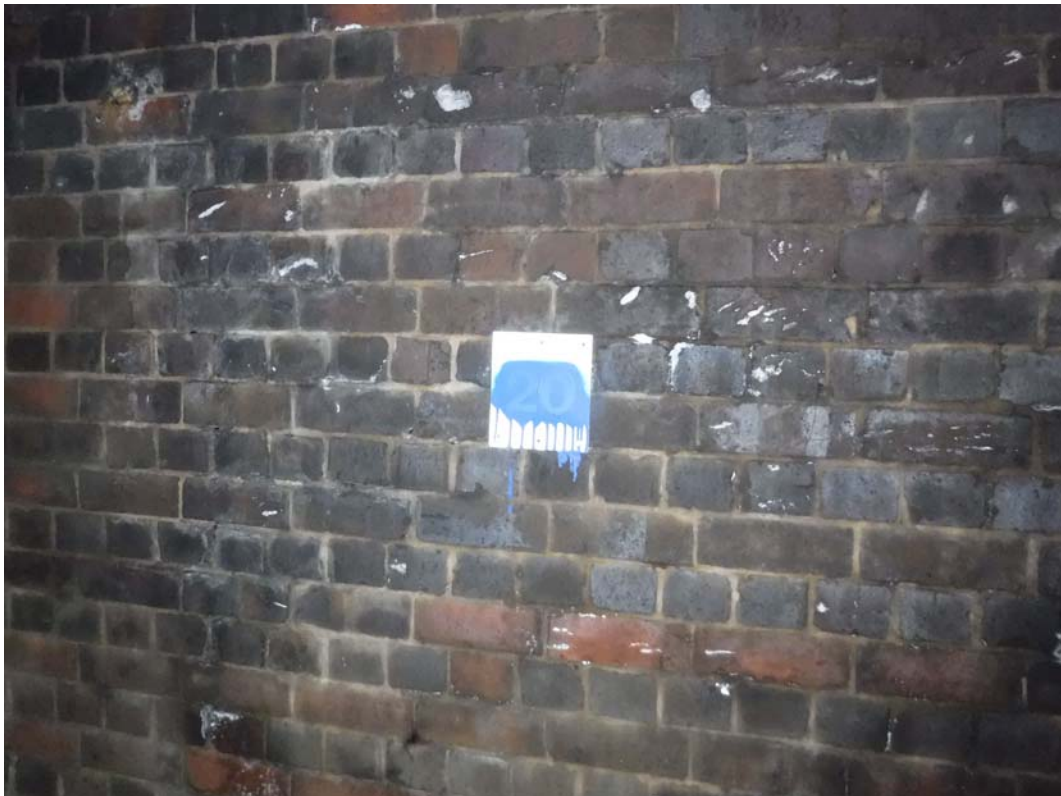
Photo No. 12 : 013+00 to 021+00 Sidewall Up, Typical views showing more tablet markers recently defaced by trespassers.

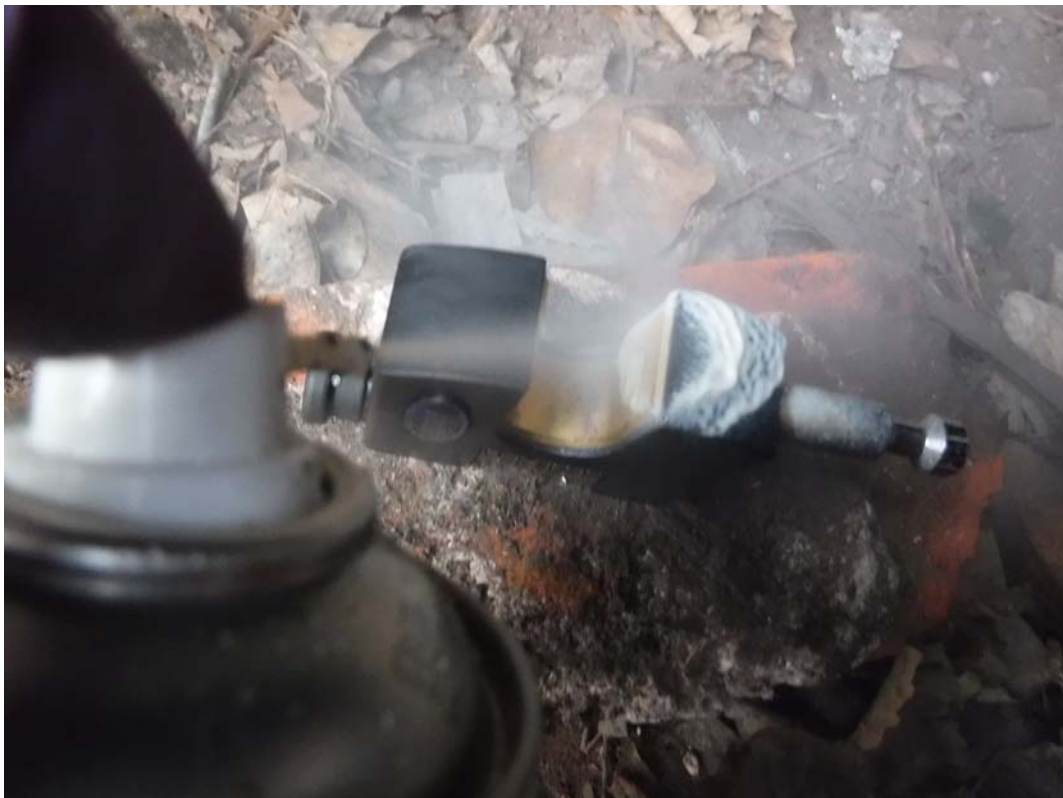
Photo No. 16 : 025+11 Linley Halt Portal, Up & Down, Presthope Portal, oiling padlock.

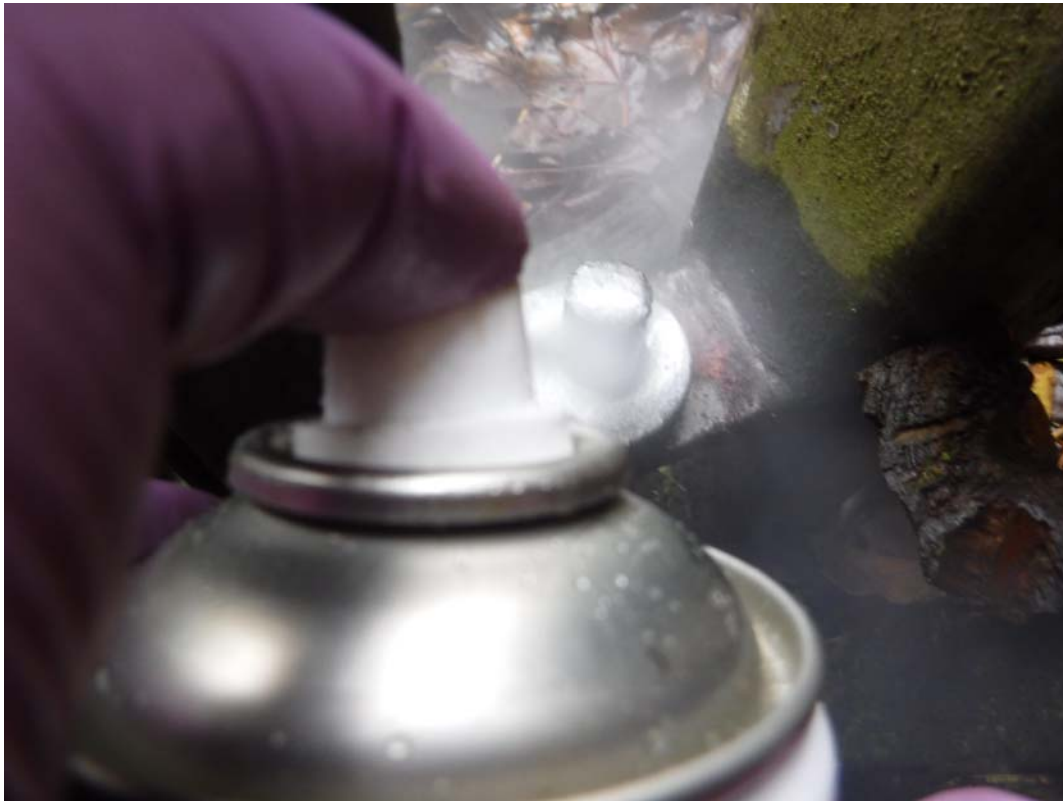
Photo No. 17 : 025+11 Linley Halt Portal, Up & Down, Presthope Portal, oiling hinges.

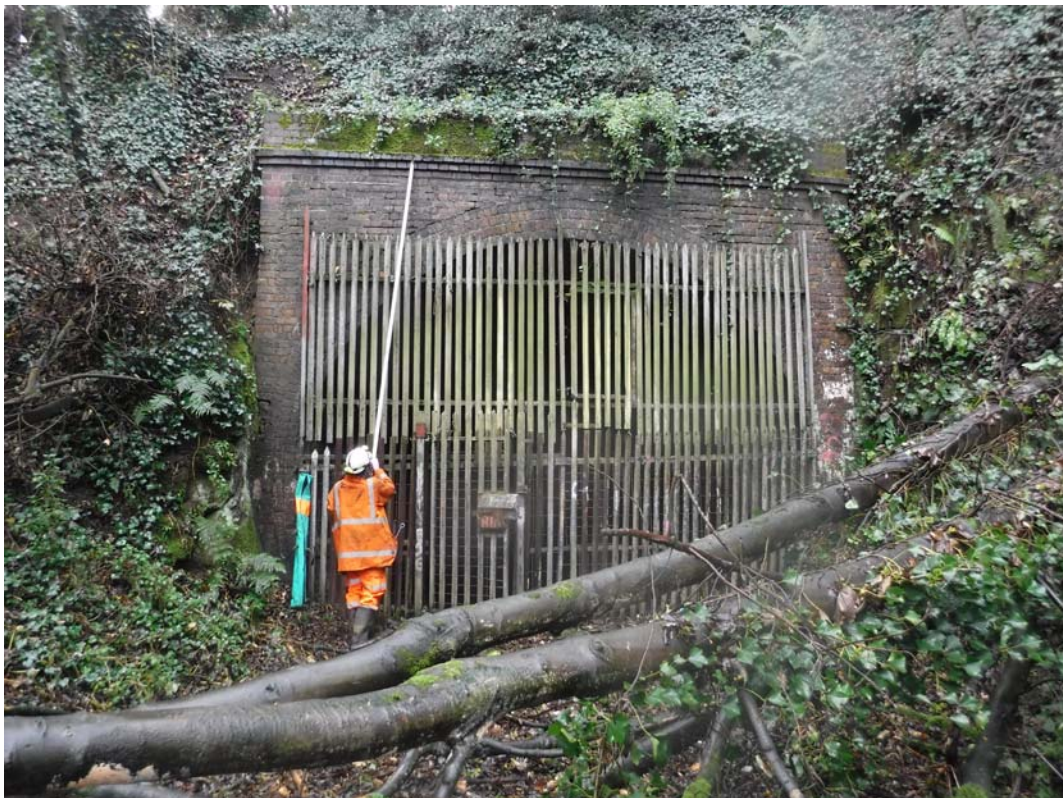
Photo No. 18 : 025+11 Linley Halt Portal, Up & Down, Brickwork, overgrown with vegetation above stringcourse, area 15sq.m.

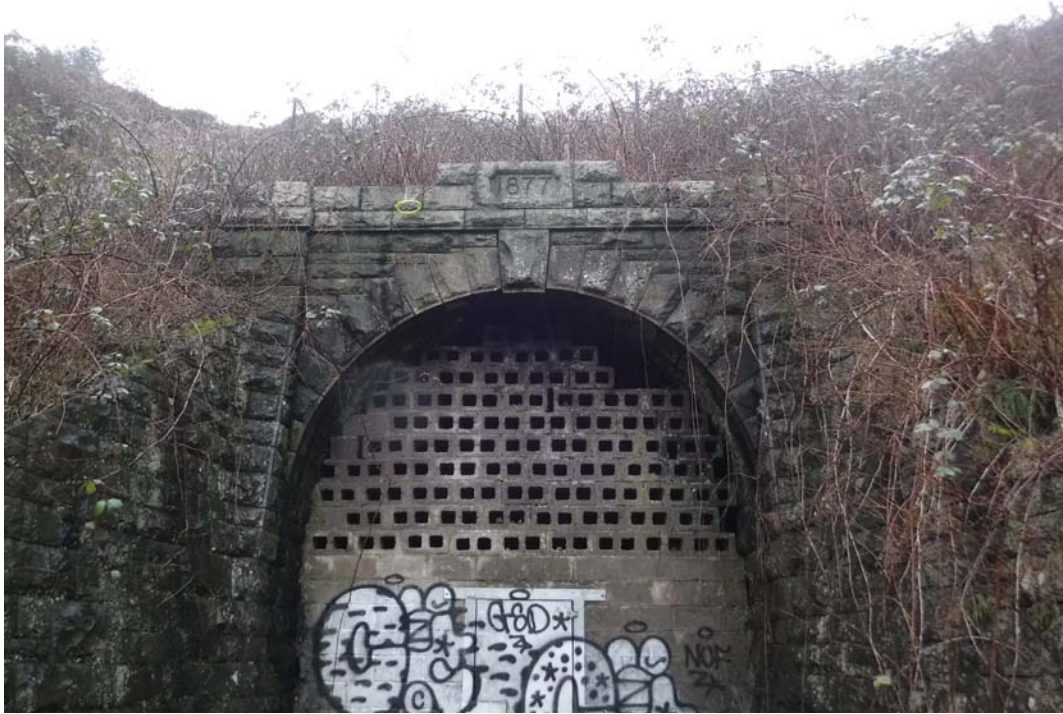
Photo No.3 : 000+00 Portal Up & Down, South Portal, stonework, vegetation, area 15sq.m.

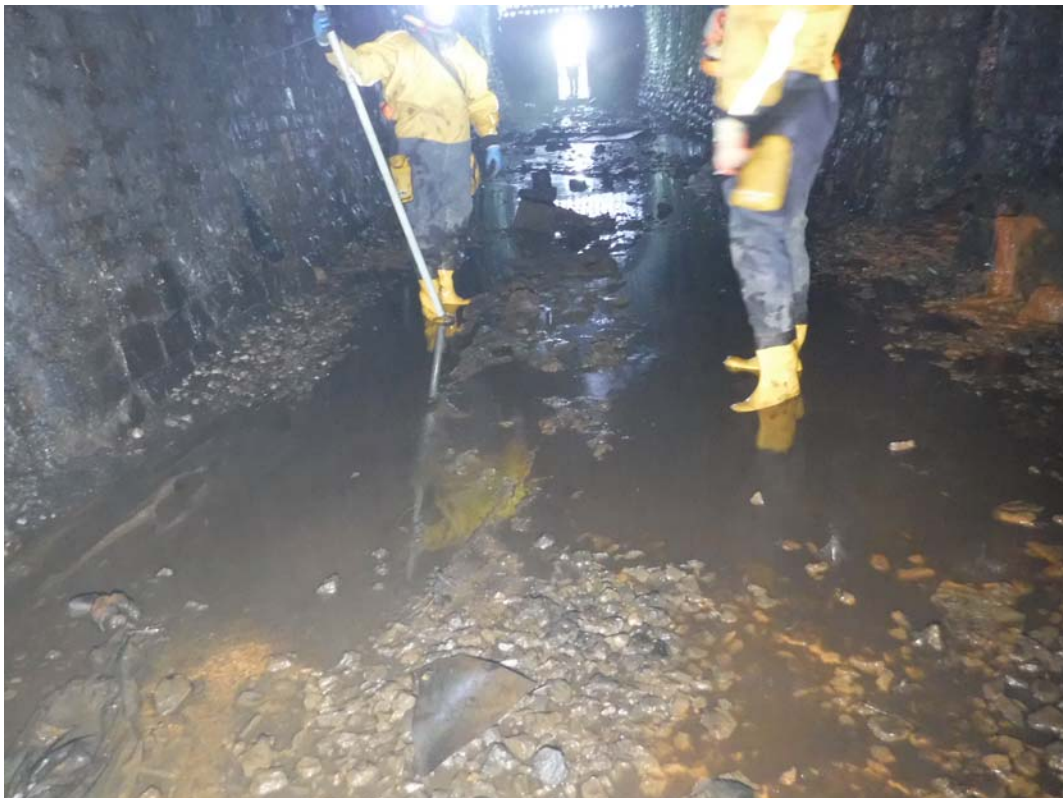
Photo No.6 : 000+00 to 03+00 Solum Up & Down, Boulders and debris underfoot making access difficult.

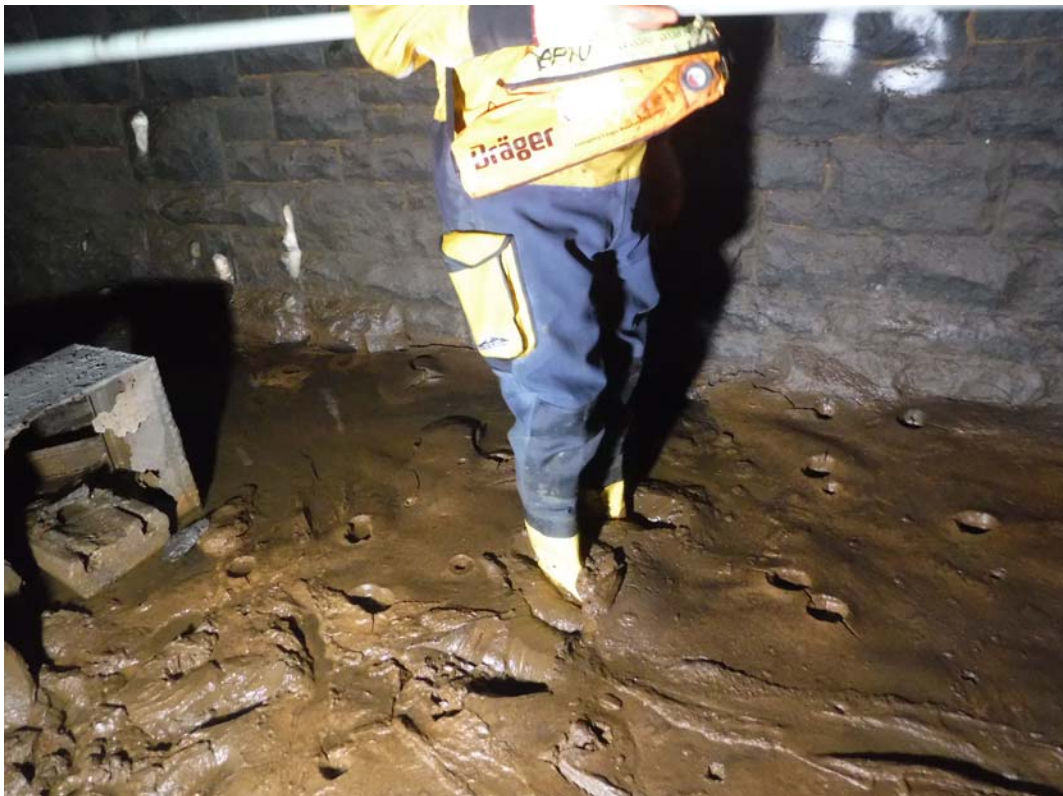
Photo No.18 : 072+00 to 072+15 Solum Up & Down, Mud and flooding, depth 3".

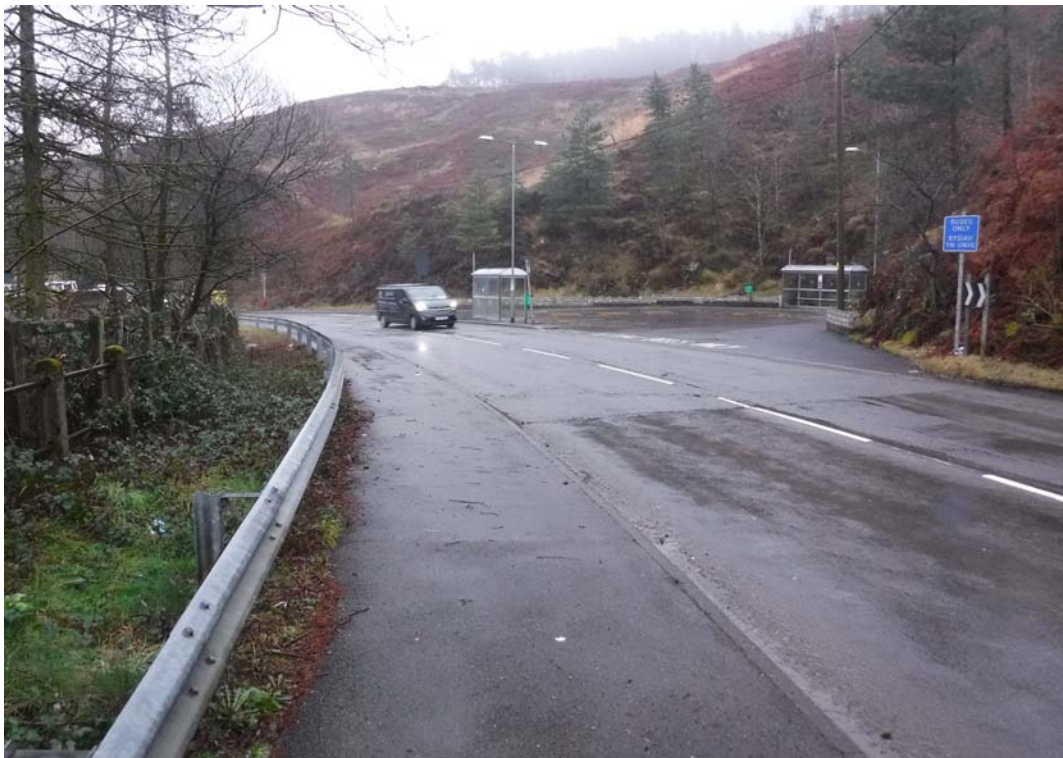
Photo No.20 : 073+05 Portal Location, North Portal, road running above portal.

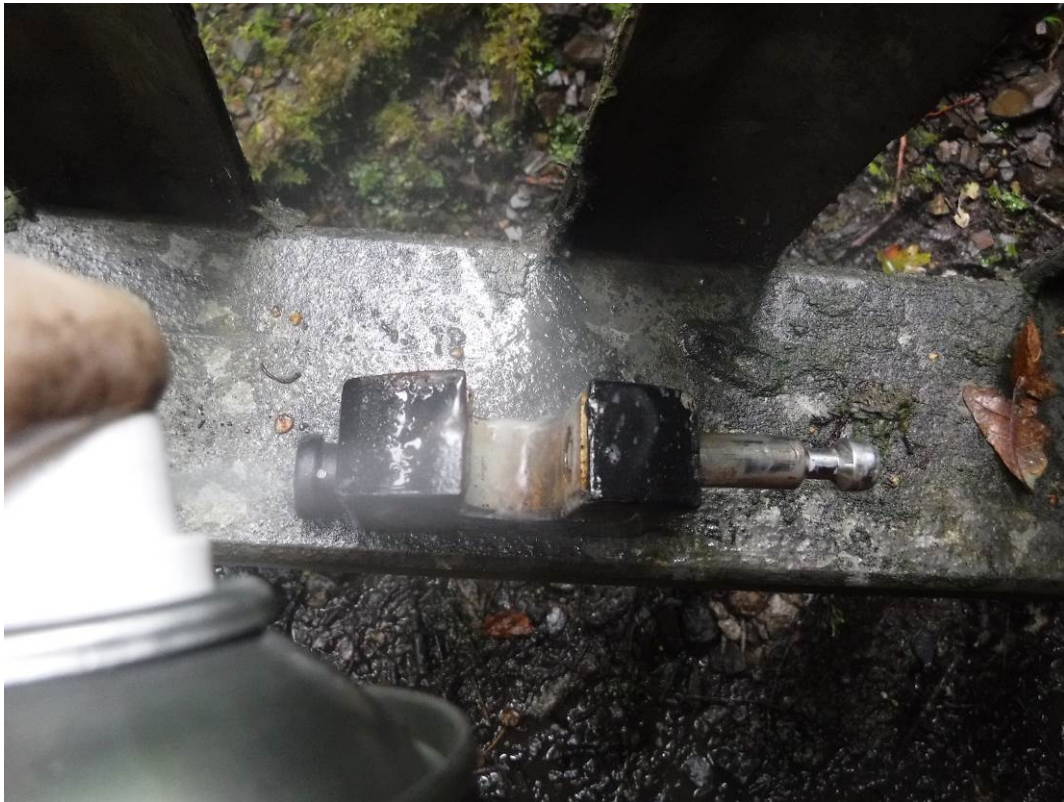
Photo No.11: 009+07 Portal Up & Down, Neath Portal, oiling gate padlock.

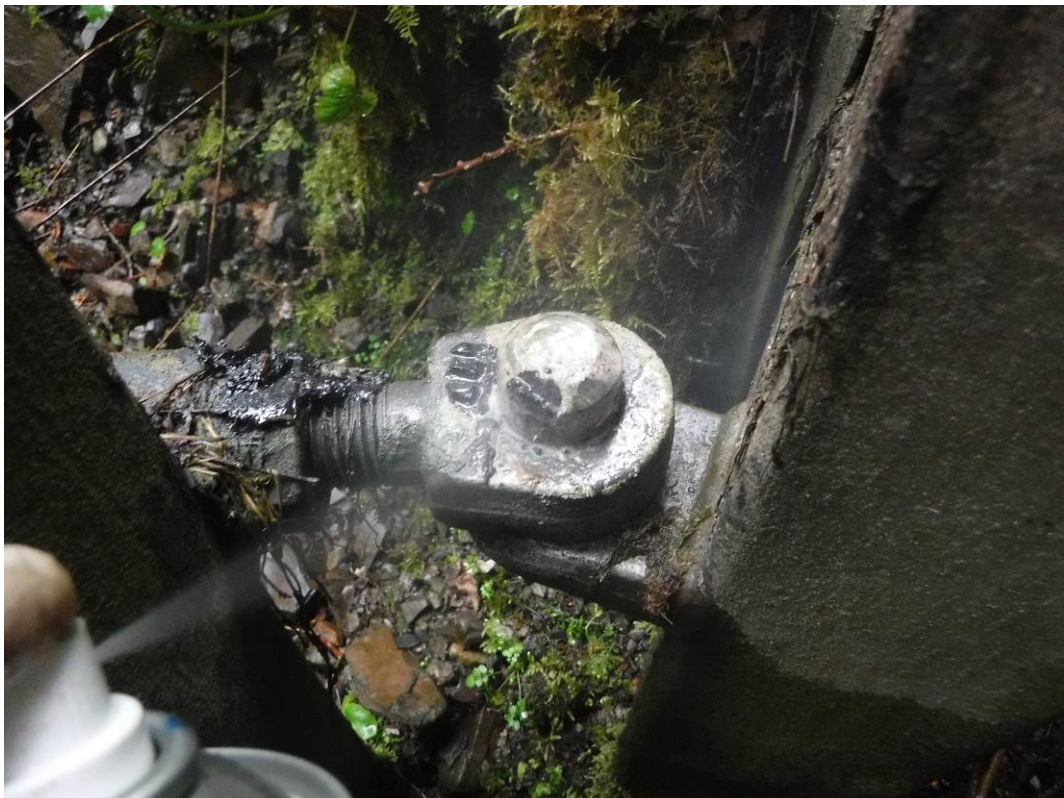
Photo No.12: 009+07 Portal Up & Down, Neath Portal, oiling hinges.

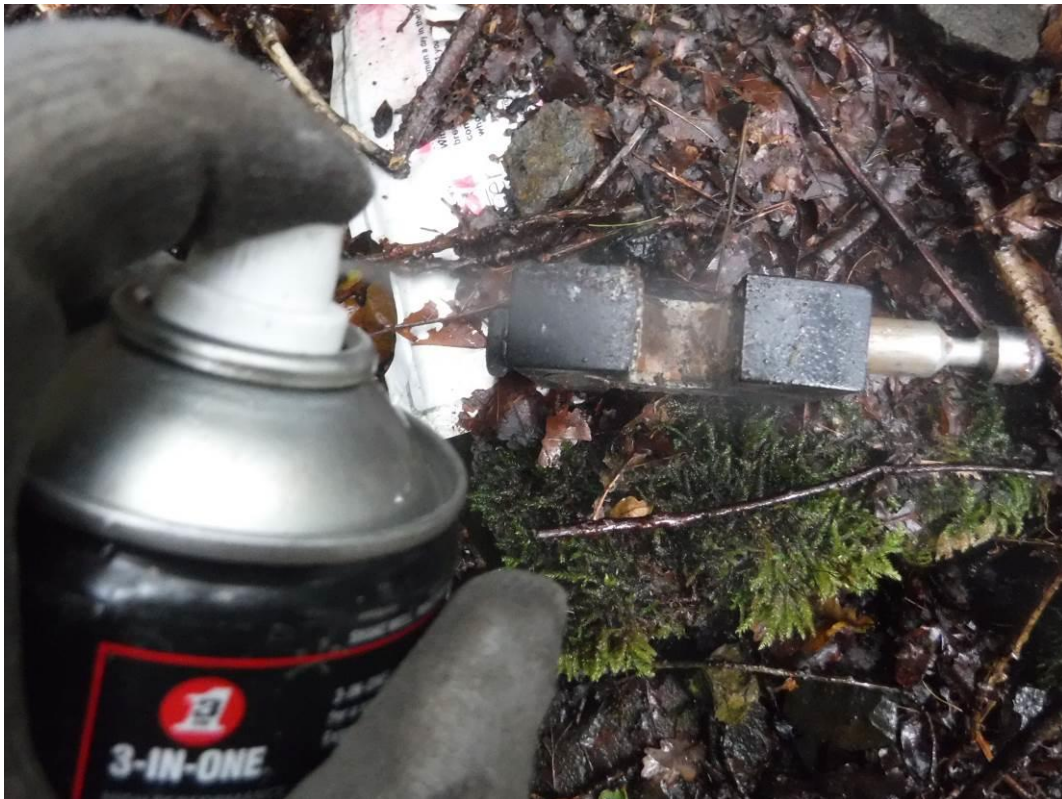
Photo No.3: London Portal, oiling gate padlock.

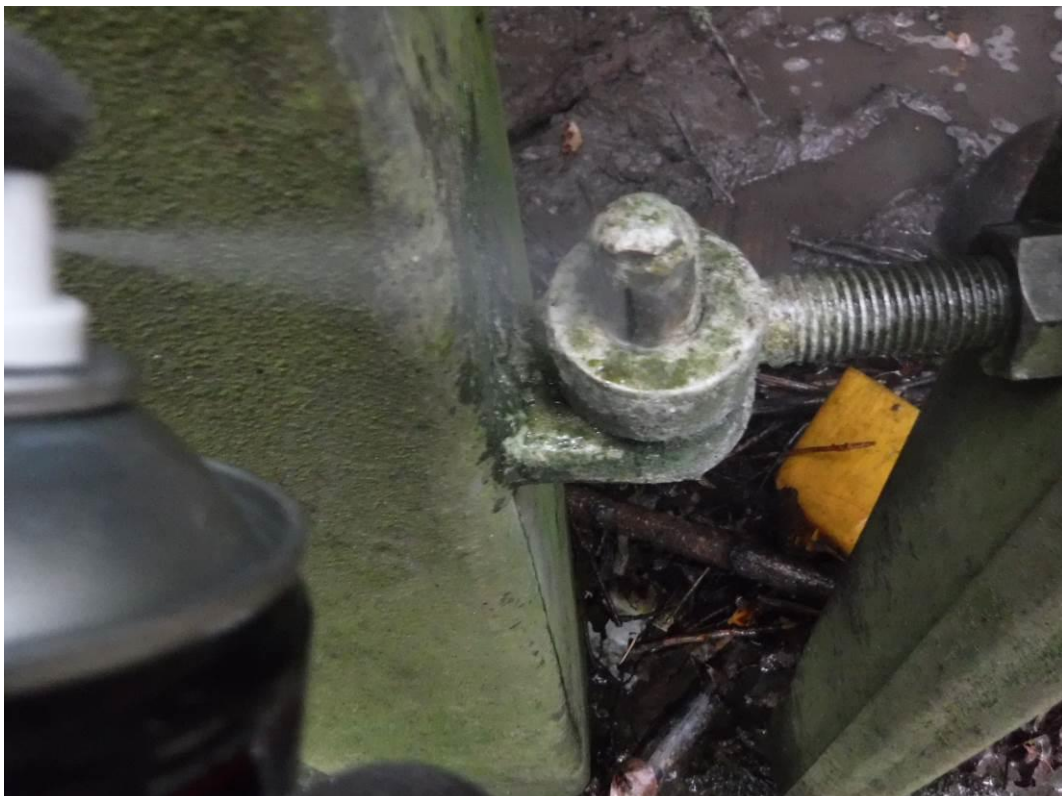
Photo No.4: London Portal, oiling gate hinges.

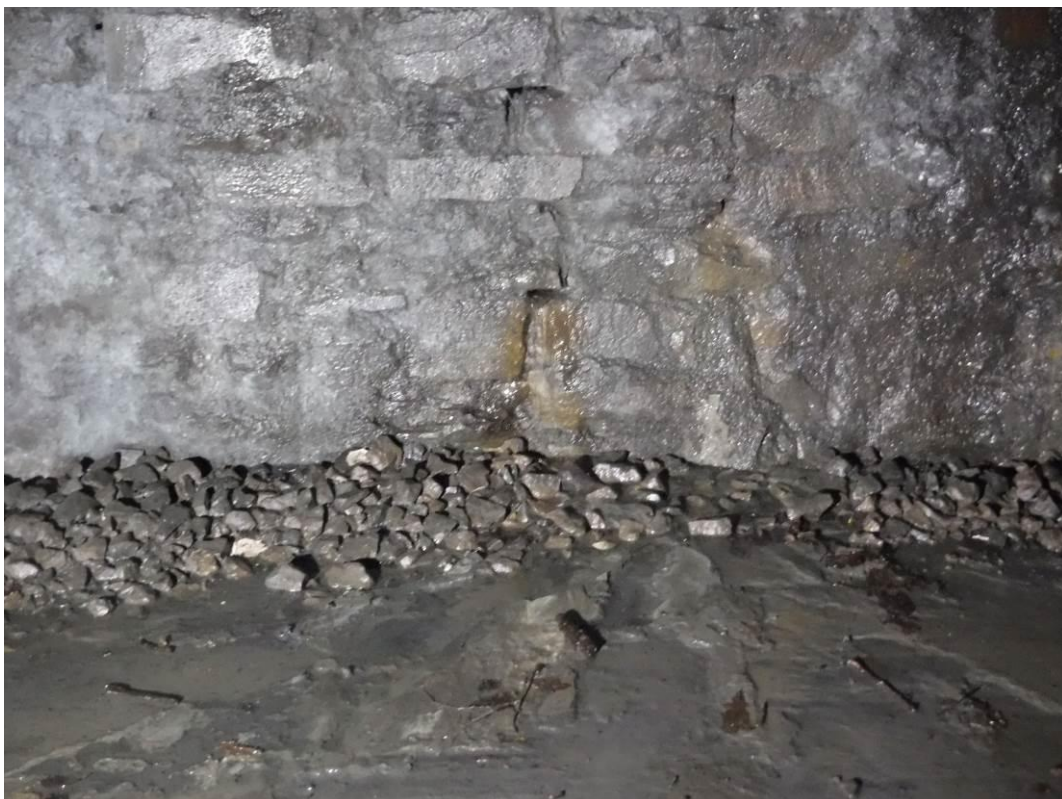
Photo No.6: 003+01 Sidewall Down, Stonework, base, weep hole, water washing fines onto solum and diffusing eastwards.

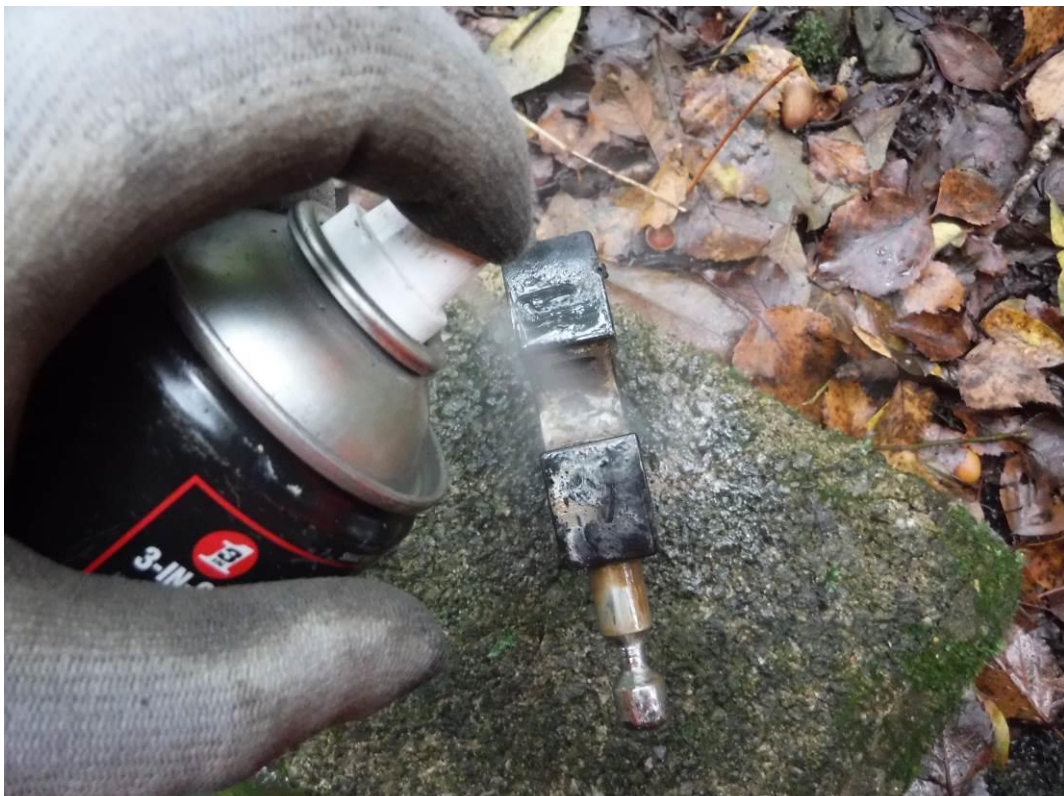
Photo No.18: 010+20 Portal Up & Down, Country Portal, oiling gate padlock.

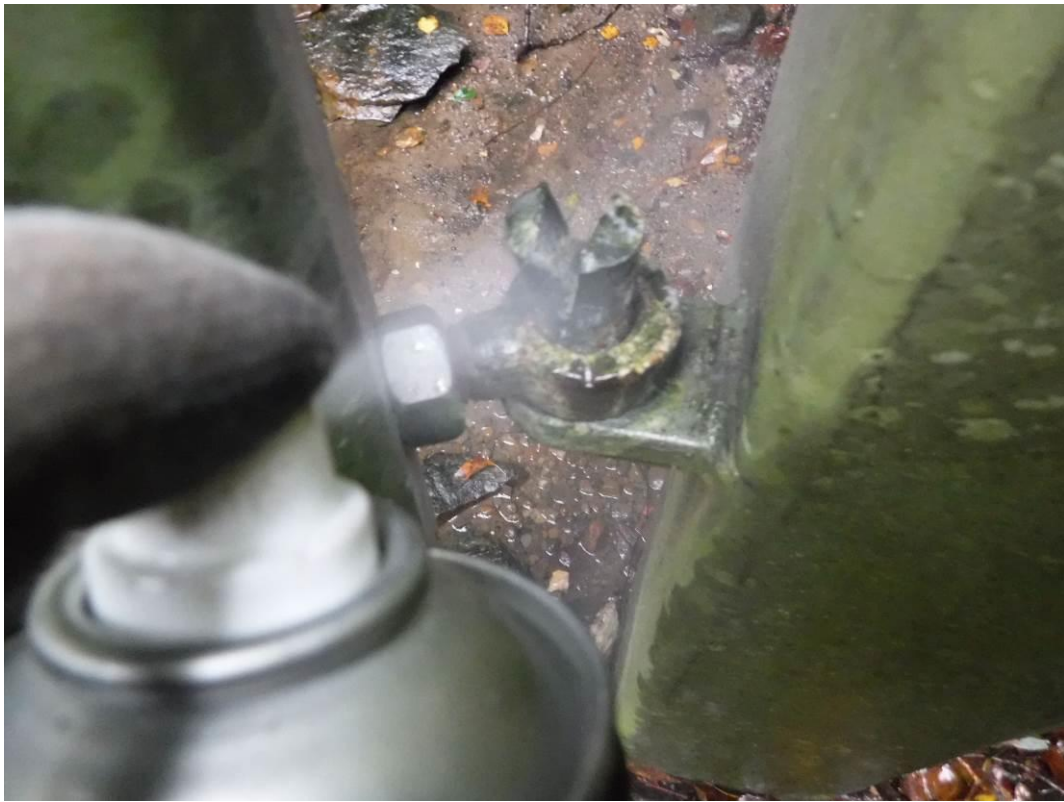
Photo No.19: 010+20 Portal Up & Down, Country Portal, oiling gate hinges.

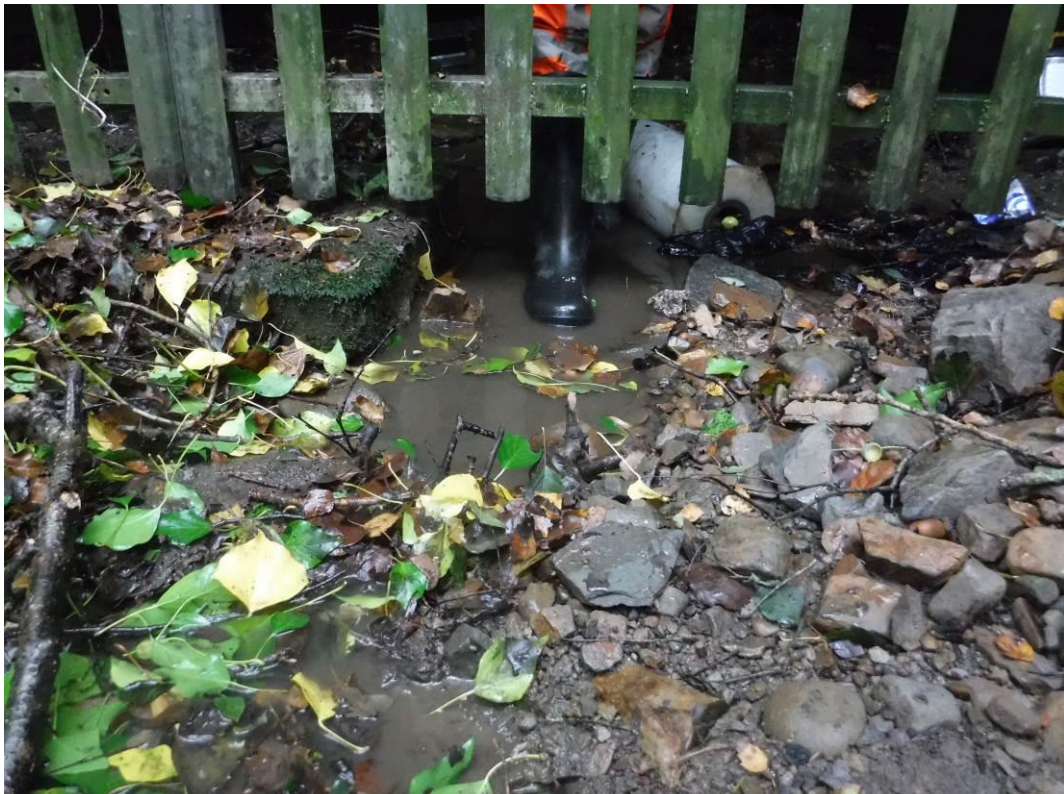
Photo No.20: 010+20 Portal Down, Country Portal, gap under gates allowing trespass.
