<b>ELR:</b>	SAD	<b>Structure No:</b>	77	<b>Mileage:</b>	19m 52ch	<b>Examination date:</b>	13/06/18
<b>Route:</b>	Somerset and Dorset					<b>OS ref:</b>	ST 615 451
<b>Name:</b>	Windsor Hill New Tunnel					<b>Type:</b>	Tunnel

<p><b>General view of structure: CE portal</b></p>

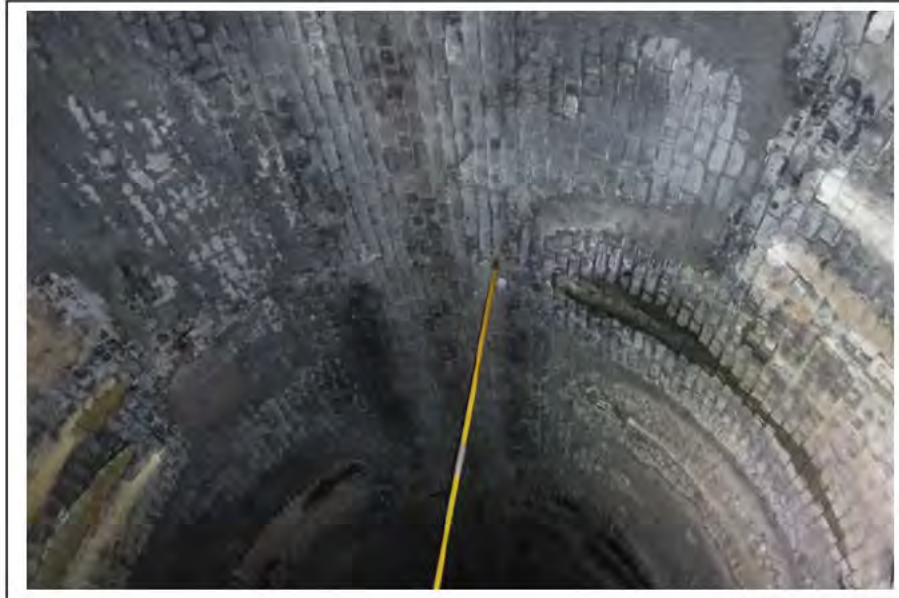
Photograph no 11: Crown at 3ch in good condition

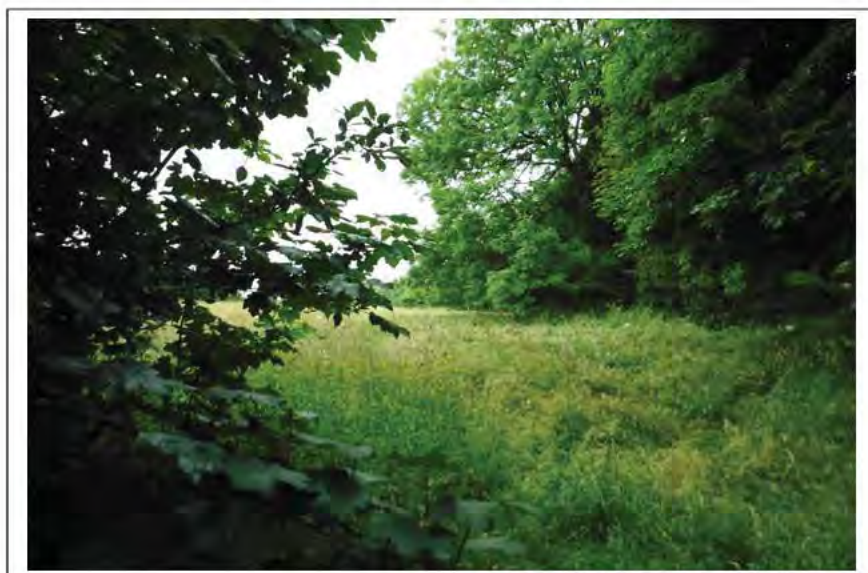
The structure carries agricultural land, woodland, and a single carriageway unclassified road. No deformation or subsidence of the road surface was observed (P32). Walkover survey not fully completed due to dense vegetation, underfoot conditions and fallen trees. The post and wire boundary fence above the CE portal has partially failed (P31). This old fence line is 5m from road with 12m drop beyond the fence line (P29, P30). The LE portal is in remote woodland (P33).

Photograph no 33: The LE portal is in remote woodland

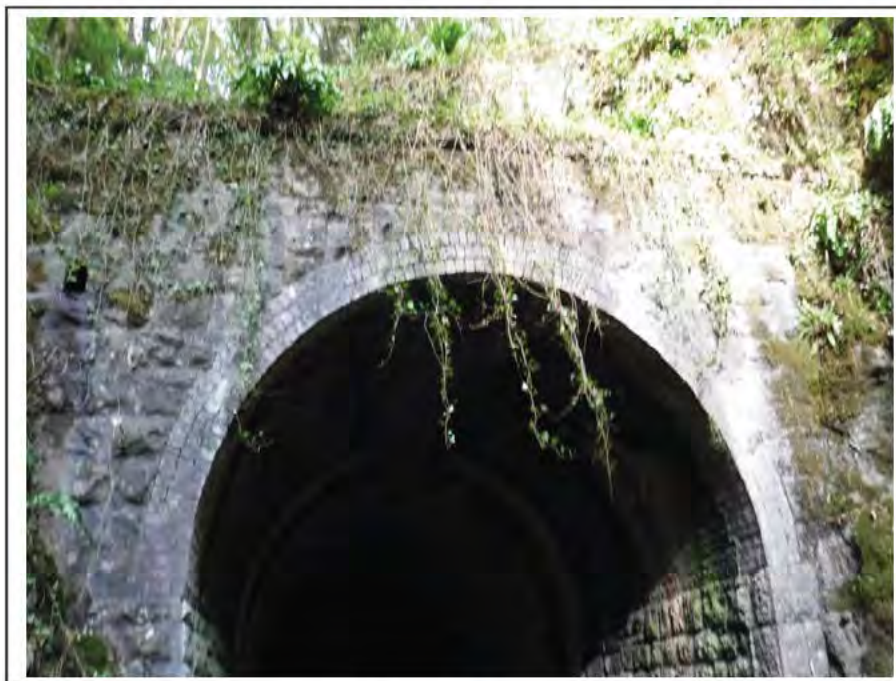
Photograph no 1: No change to minor defects at CE portal

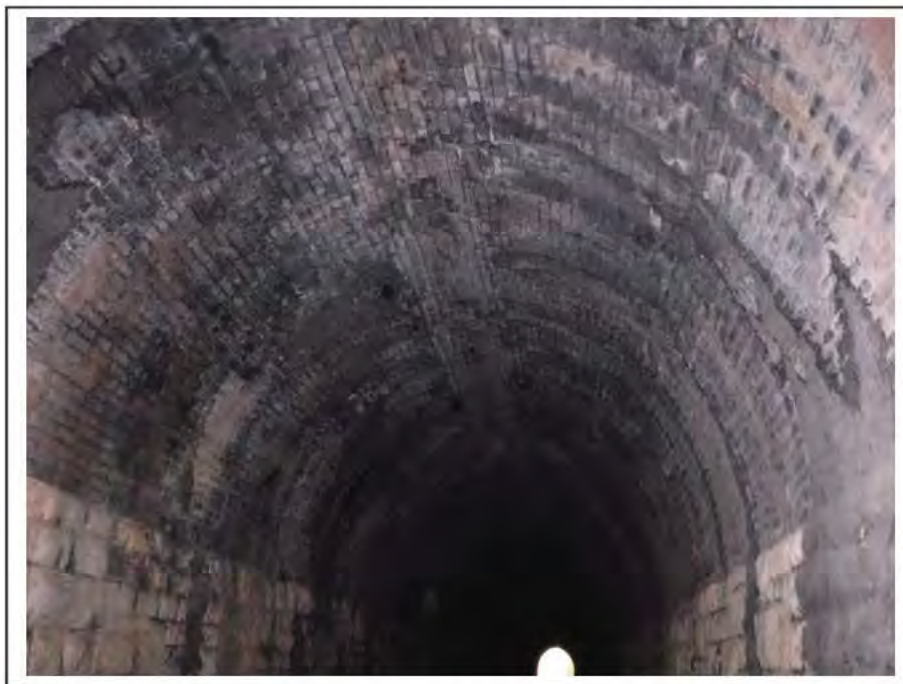
Photograph no 3: Barrel is in good condition throughout

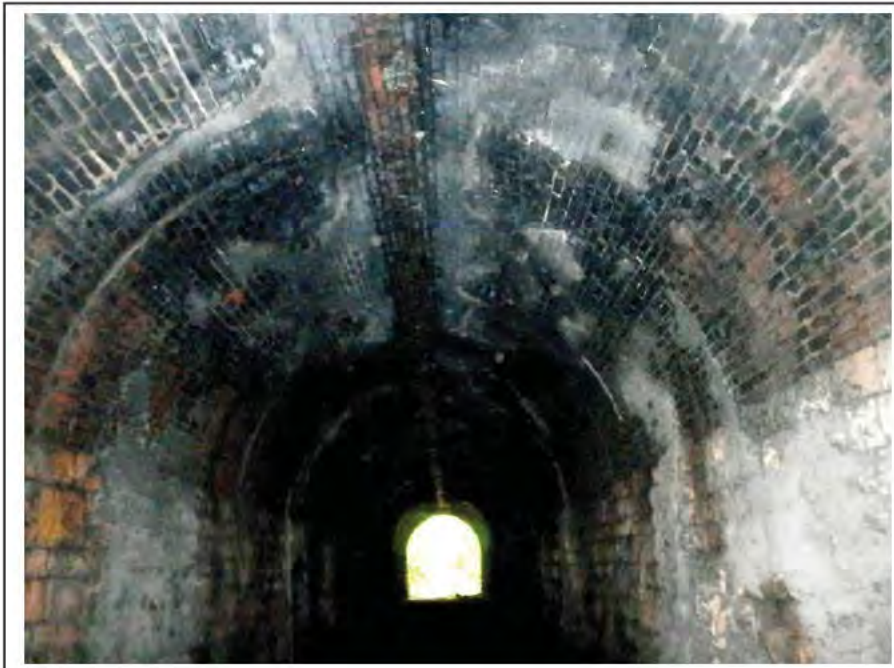
Photograph no 3: barrel remains in good condition (view to CE)

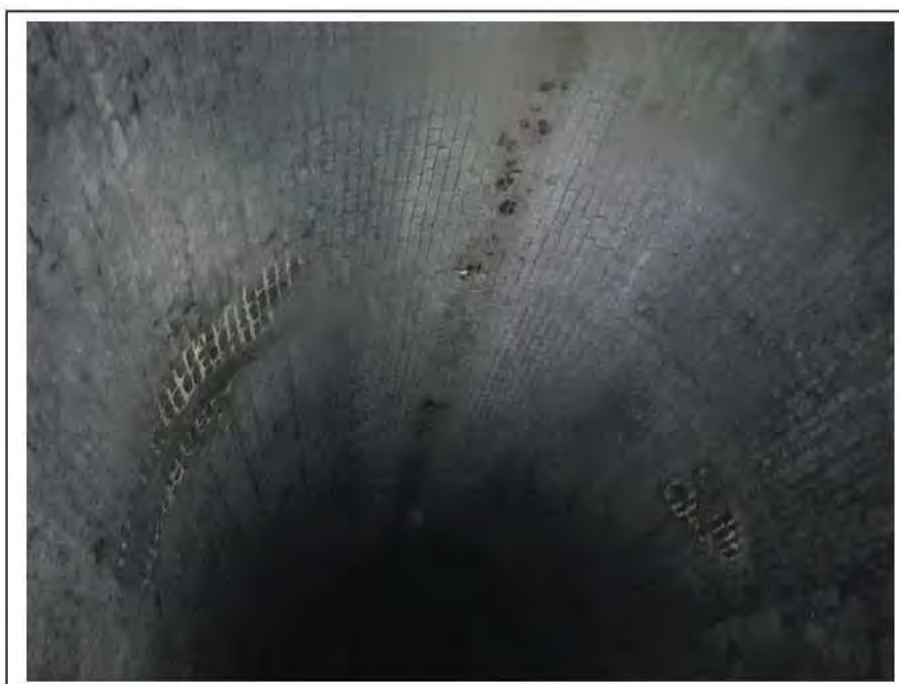
Photograph no 4: barrel in very good condition and dry throughout

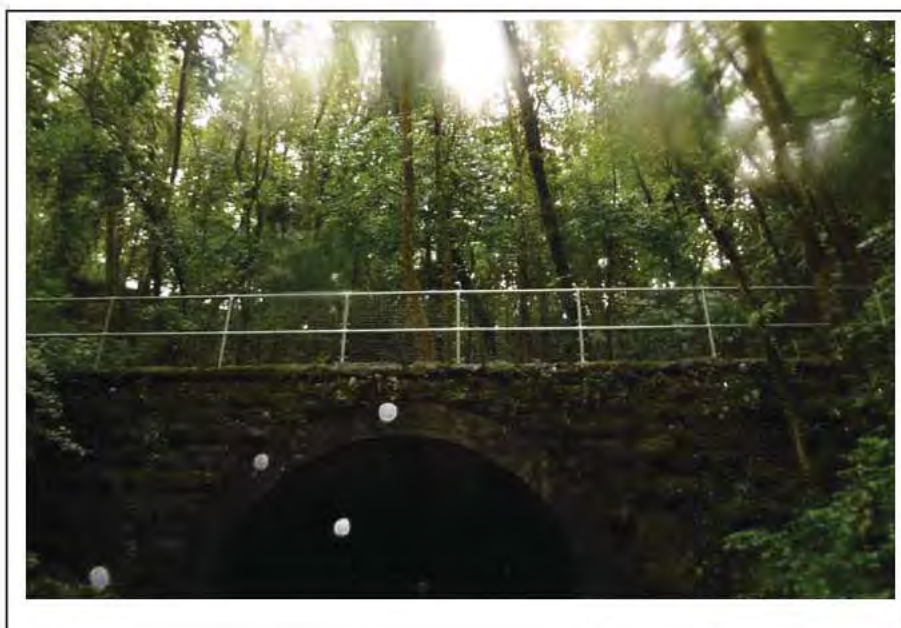
Photograph no 6: New fencing installed to rear of UC portal is found intact throughout

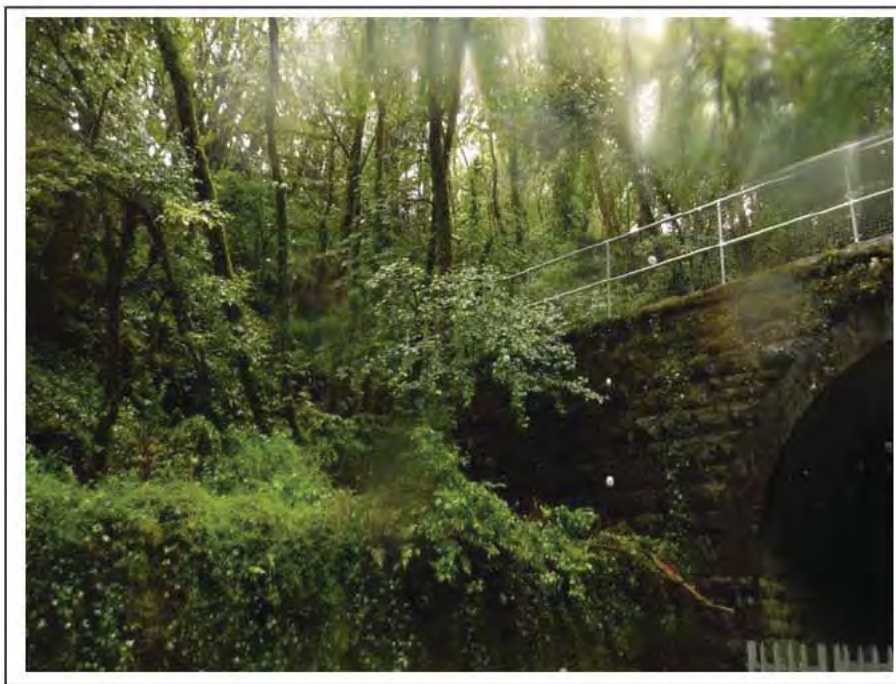
Photograph no 7: New fencing installed to rear of UC portal is found intact throughout

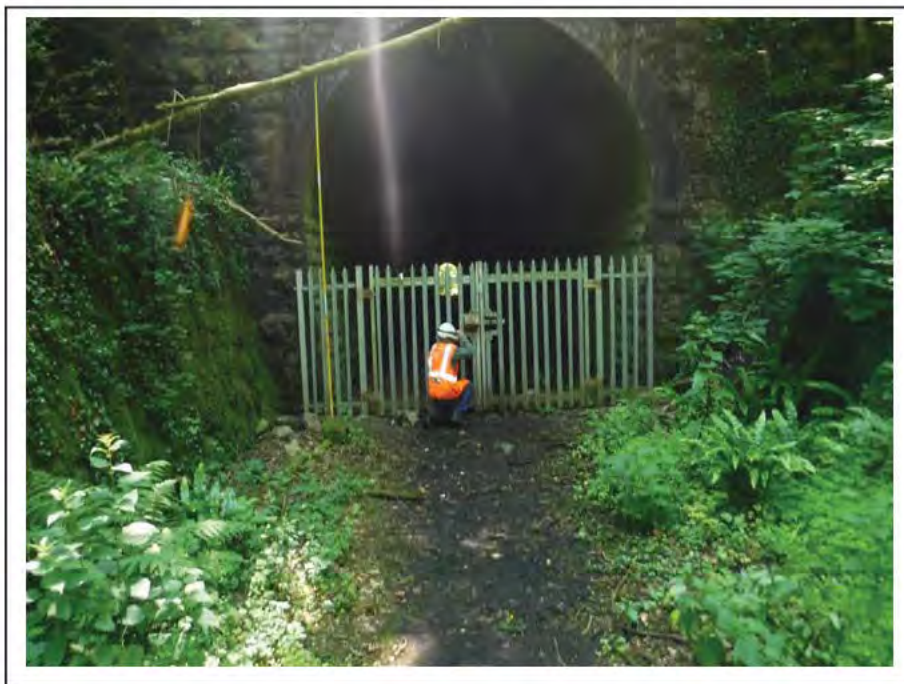
Photograph no 1:  
LE security fencing

<b>Pressure readings</b> LE – 1024.1mb Centre – 1024.1mb CE – 1023.9 mb		<b>Gases</b> O <sub>2</sub> – 20.9% H <sub>2</sub> S – zero CH <sub>4</sub> – zero CO - zero CO <sub>2</sub> – 147ppm	
<p><b>Recommendations:</b>          Repair damage to LE formation fencing and replace mesh to CE portal fencing - P1 £750.</p>			
<b>Signed by Examining Engineer:</b>

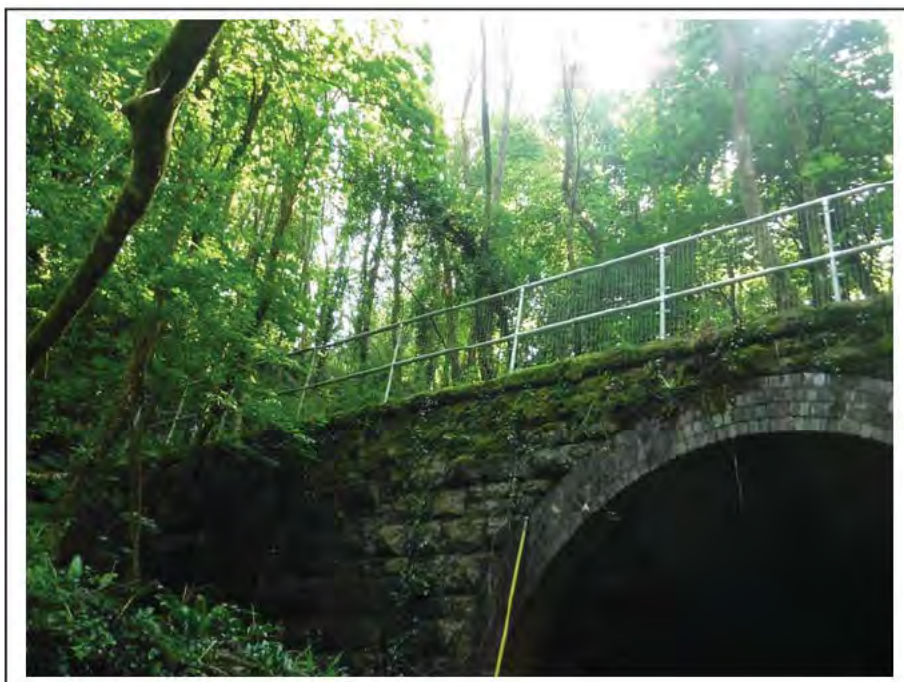
Photograph no 4:  
Fencing to rear of headwall found secure

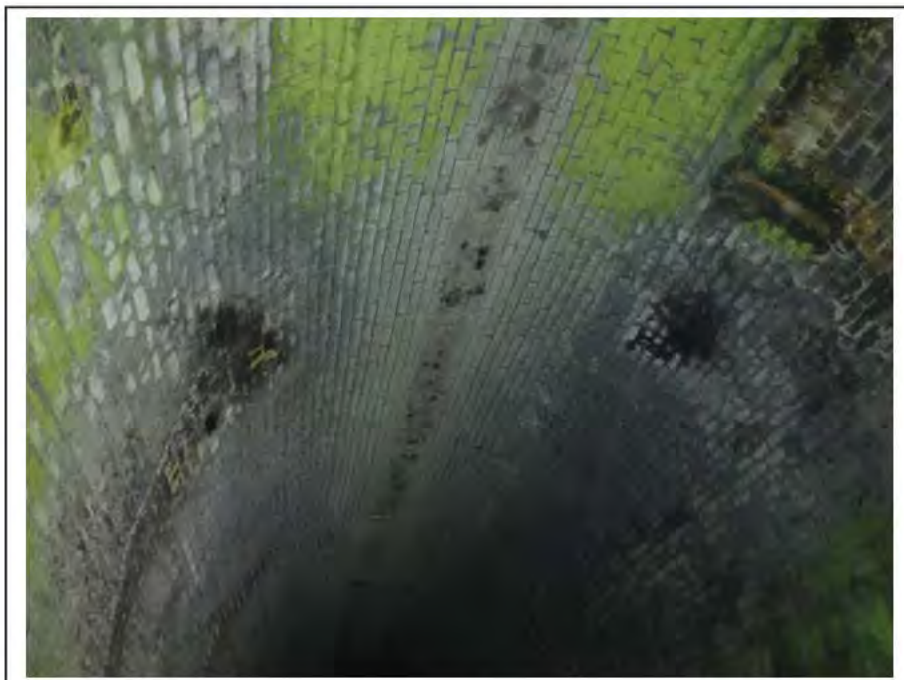
Photograph no 6:  
Barrel in good condition throughout – view to CE from LE portal

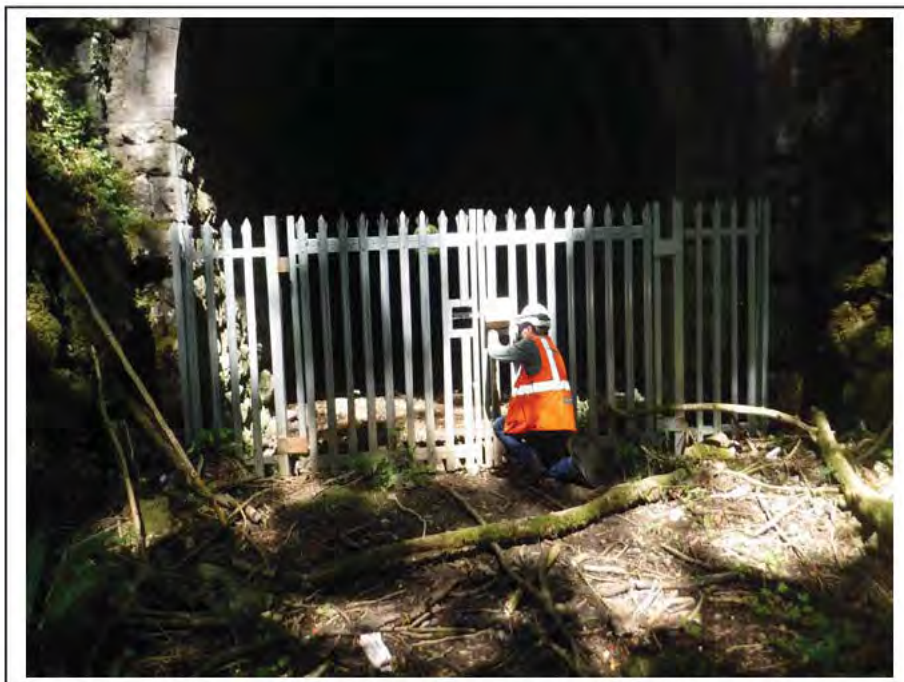
Photograph no 8:  
CE fencing at formation found secure

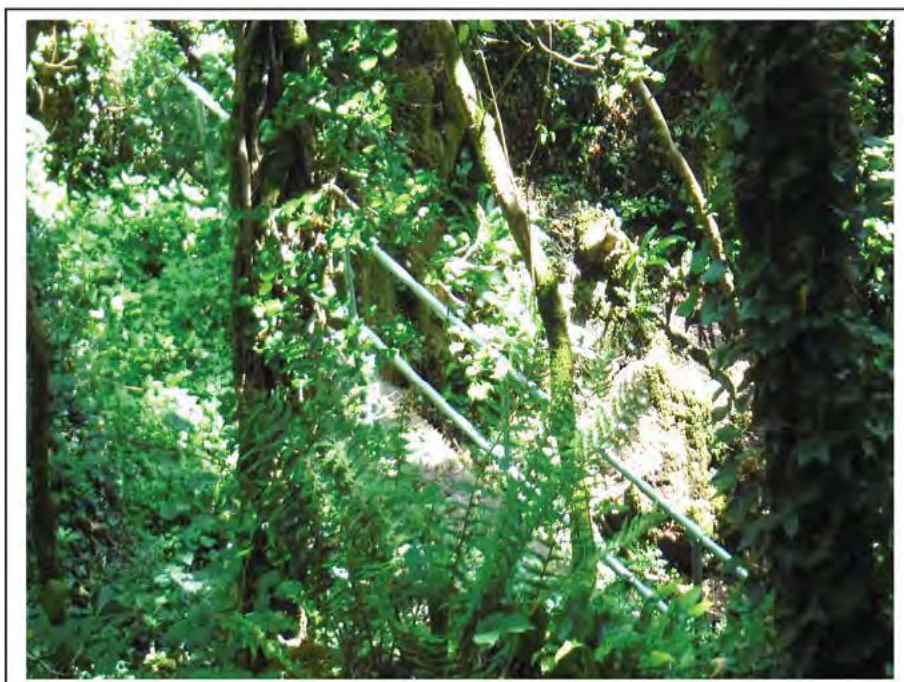
Photograph no 12:  
Ce portal fencing from road level (approx. 12m above)
